DAI MSB40-012 Page 1 of 5 19-Jul-2002

MANDATORY SERVICE BULLETIN NO. MSB 40-012

Mixture Control Cable

ATA-Code: 76-10

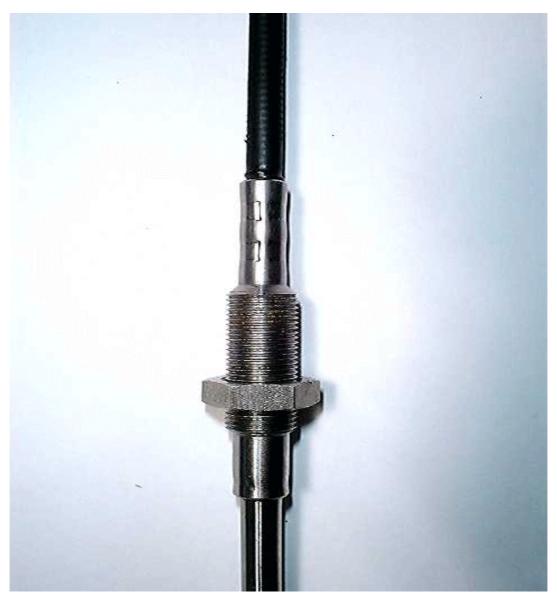
Picture 1

At some mixture control cables in case of high friction within the cable the crimp of the cable may fail, so that the mixture can not be adjusted anymore.

The critical type of mixture control cable can be identified by type of crimp.

- 2. If the installed mixture control cable has a crimp like shown in Picture 1, it should be replaced by mixture control cable part number 45.0350 in accordance with Airplane Maintenance Manual (AMM) Doc. No. 6.02.01.
- 3. If the installed mixture control cable has a crimp like shown in Picture 2, there is no further action required.
