# G1000 System Maintenance Manual

## Diamond DA 40 & DA 40 F With GFC 700 or KAP 140 AFCS

Contains FAA-Accepted Instructions  
For Continued Airworthiness For  
STC SA01444WI-D

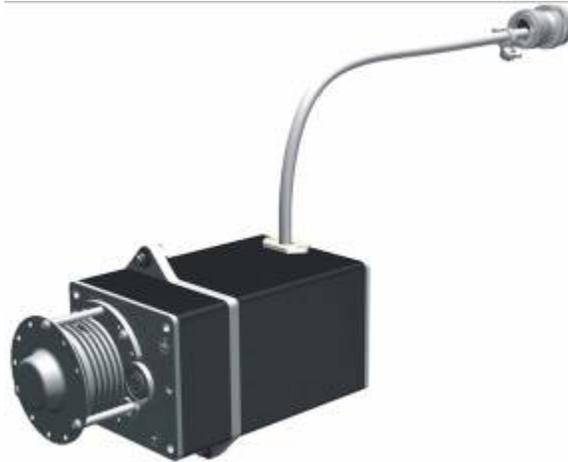
**Figure 2-2. GSA 81 & GSM 85**

The GSA 81 is mated to the GSM 85 Servo Mount to form a single servo unit. There are three servo units in this installation:

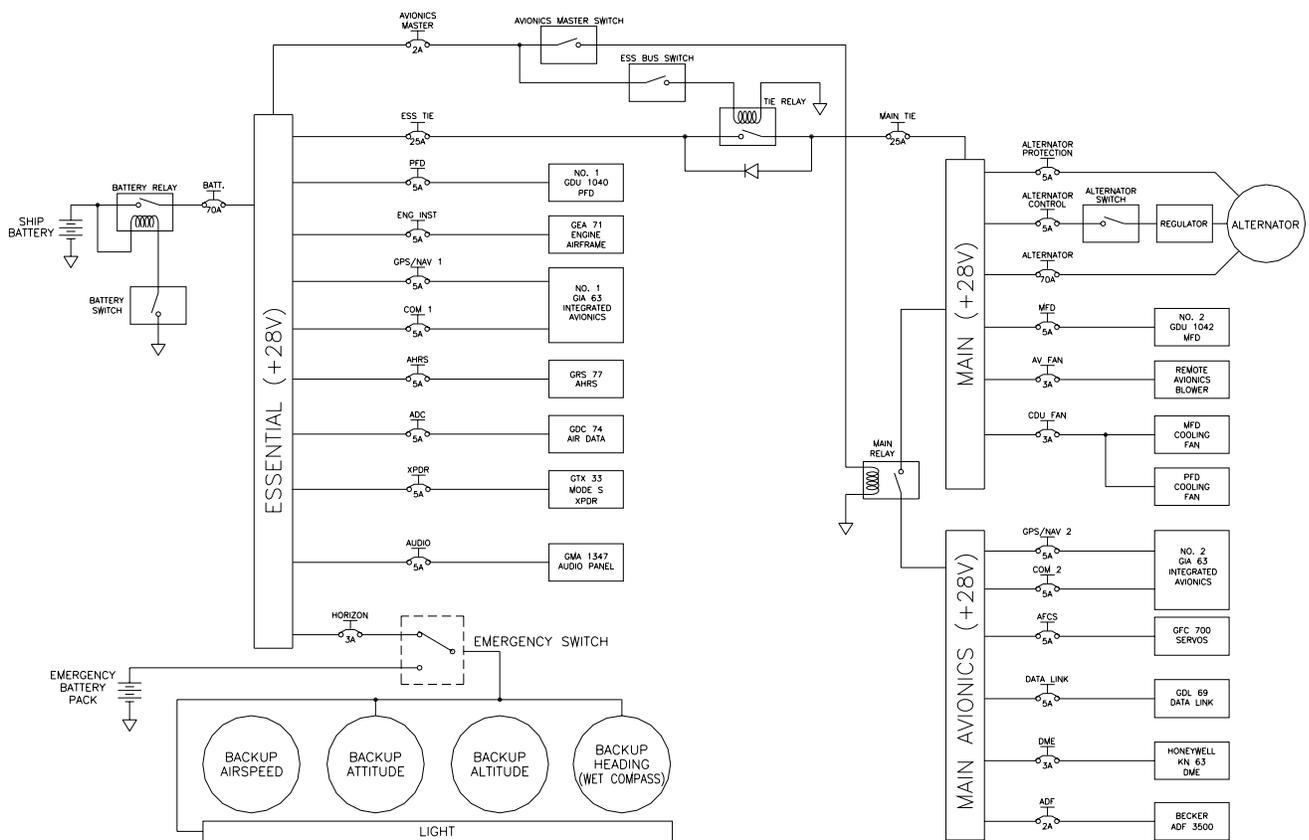
Figure 2-3. G1000/DA40 Electrical Distribution

**Main Aircraft Bus:** The ‘Main’ bus receives power from the aircraft battery when tied to the ‘Essential’ bus. After the aircraft engine is started, the alternator supplies power to the aircraft ‘Main’ bus, and to the rest of the system. In the event of an alternator or other power failure, the ‘Essential’ bus can be isolated with the ‘Essential Bus’ switch. This causes the ‘Essential’ bus to revert to battery power. Only the MFD receives power from the ‘Main’ bus.

**Main Avionics Bus:** A ‘Main Avionics’ bus is tied to the ‘Main’ aircraft bus via the ‘Avionics Master’ switch and switch relay. The #2 GIA 63, the ADF, DME, GFC 700 AFCS, and the GDL 69A are connected to this bus.

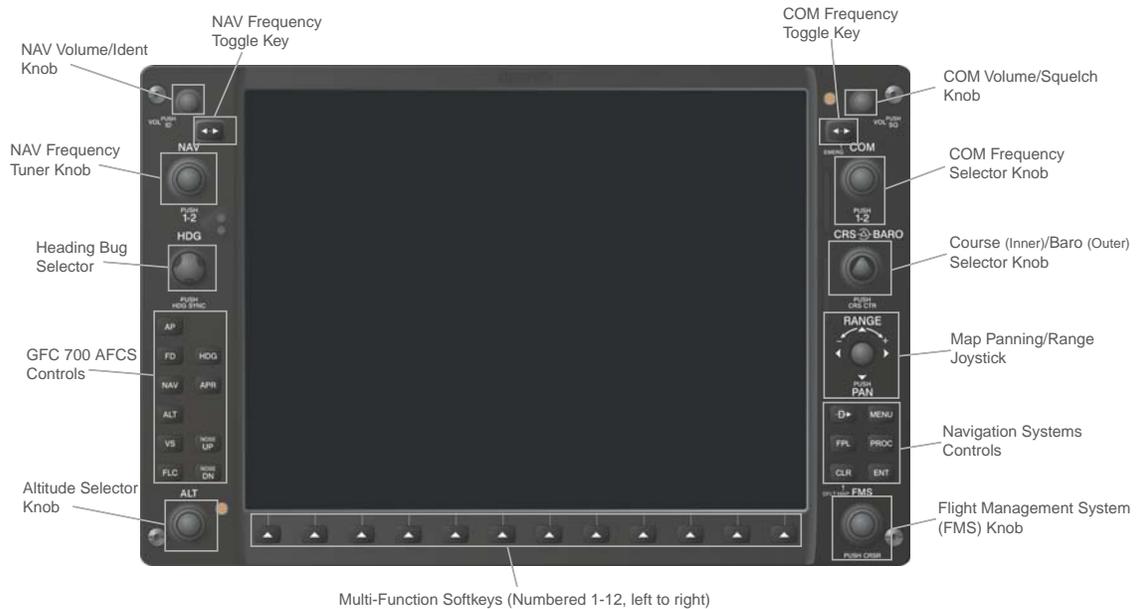
**Figure 3-1. GDU 104X Control Interface (GDU 1042 shown)**

All control and operation of G1000 equipment as normally used in flight occurs through the PFD, MFD and GMA 1347 audio panel. Figure 3-1 identifies GDU 1040 buttons. Figure 3-3 identifies various GMA 1347 buttons.

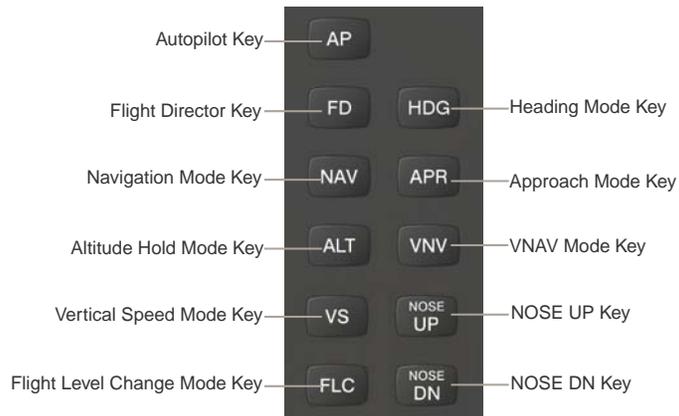
**Figure 3-2. AFCS Controls (GDU 1044 shown)**

The dedicated AFCS controls located on the GDU 1042 and 1044 are discussed in detail in the G1000 CRG. The following figure is provided for reference:

1. Check the G1000 MFD for a dedicated AFCS mode control keypad (see Figure 3-2).
2. Check the aircraft throttle lever for installation of a ‘Go Around’ (GA) button.
3. If the aircraft has these features installed, it is equipped with the Garmin GFC 700 autopilot.
4. The aircraft is either a -1 or a -2 MDL Configuration.

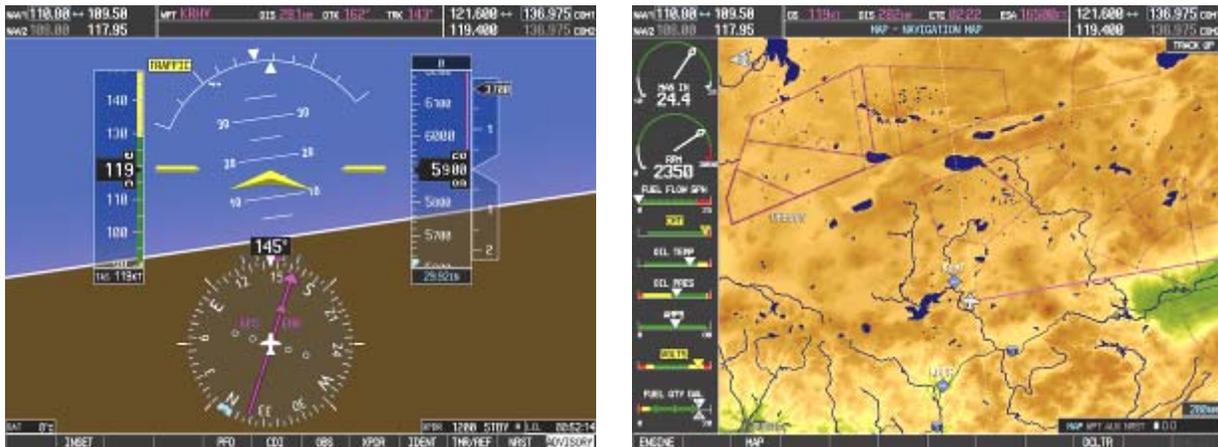
Figure 3-5. Normal Mode

The G1000 system is now powered in the normal mode. The PFD and MFD will function as specified in the G1000/DA 40 Cockpit Reference Guide, when the system has been correctly installed and configured.

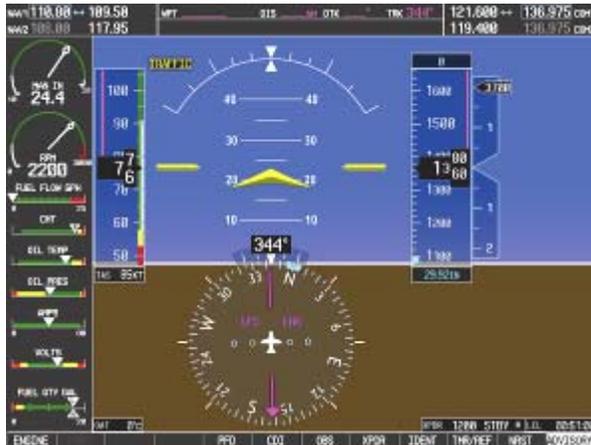
Figure 3-6. MFD Failure Mode

Should a display communication or hardware failure occur, the G1000 system automatically enters the reversionary mode. The system reversionary mode forces the remaining display into showing all information related to safe flight.

A manual reversionary mode also allows the operator to force the system into reversionary mode in situations where the system does not automatically enter reversionary mode. A large red button labeled 'DISPLAY BACKUP' on the GMA 1347 audio panel activates the manual reversionary mode.

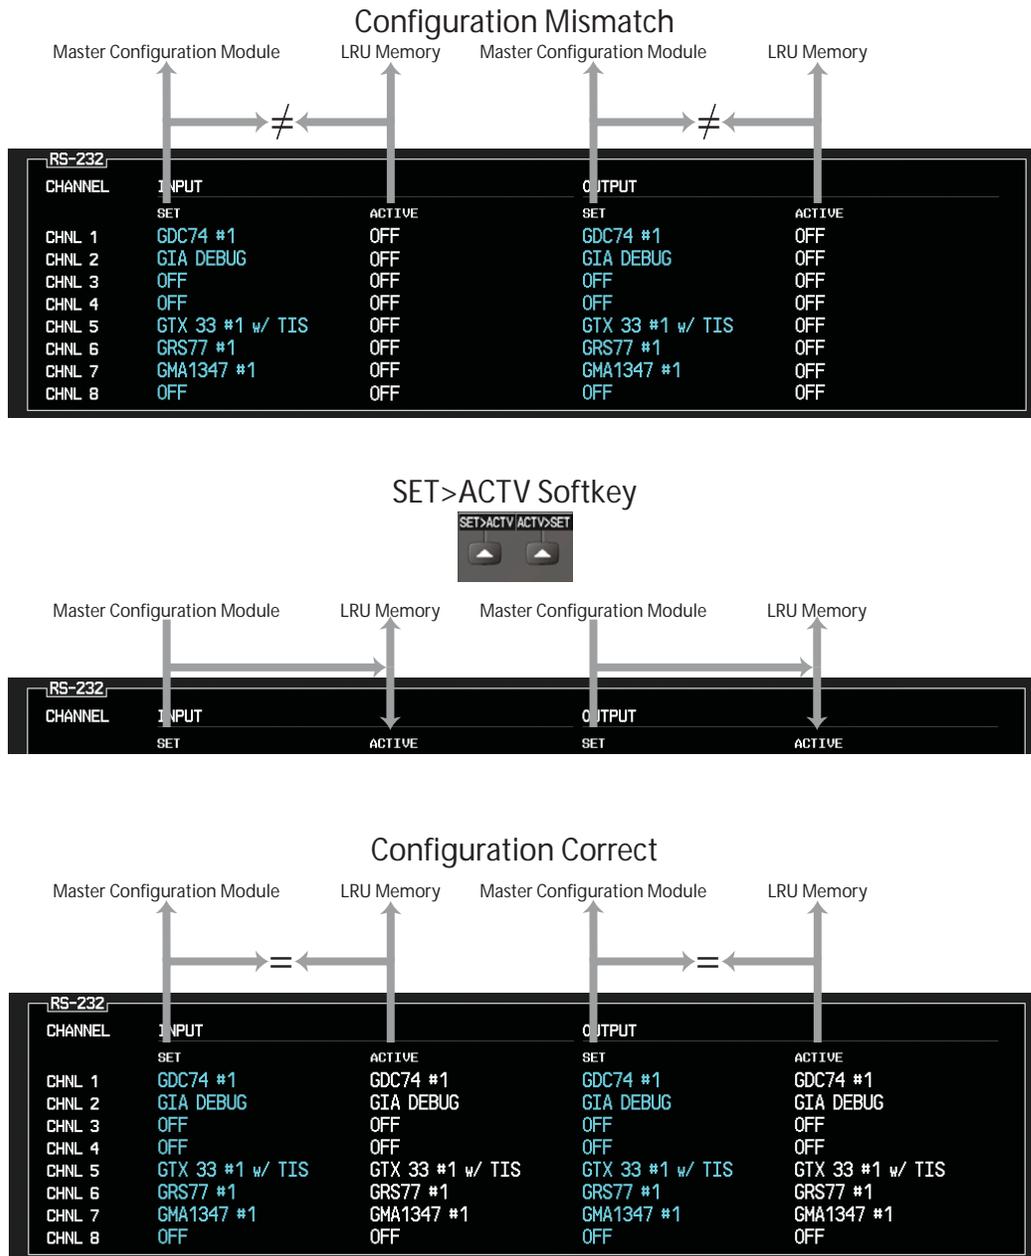
**Figure 3-8. SET>ACTV Diagram**

In the first example shown in Figure 3-8, the SET columns do not match the ACTIVE columns. The inequality between SET and ACTIVE indicates a configuration mismatch. By pressing the SET>ACTV softkey, this copies the SET column to the LRU unit's configuration memory. The settings then become the ACTIVE settings for the LRU being configured.

When troubleshooting the system, technicians can look for inequalities between SET and ACTIVE columns. Certain problems can be resolved simply by pressing the SET>ACTV softkey, which reloads settings to the specific LRU from the PFD. (Note that this can also be accomplished by reloading the configuration files for the LRU, using the approved system software version. Section 7 describes this process for each LRU).

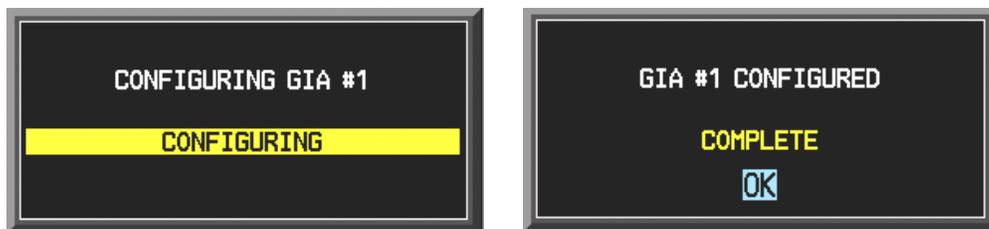
Figure 3-10. Configuration Status

When configuration settings are changed, the technician receives on-screen prompts and/or confirmations such as those shown in Figure 3-9. Section 7 shows other prompts encountered during the configuration process.

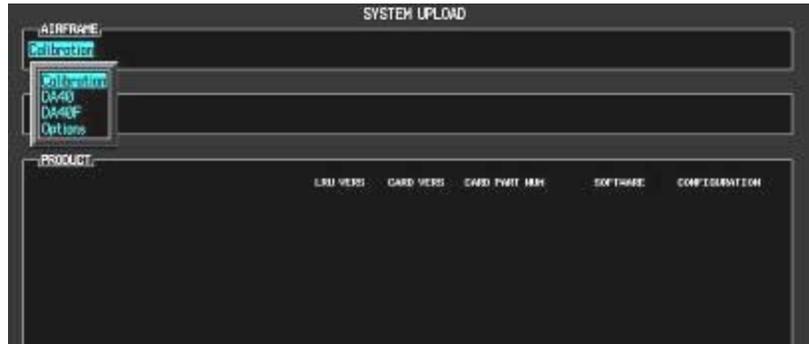
The Calibration file group is selected from the AIRFRAME menu as shown:

When selected, the Calibration file group displays two CAL configuration options in the FILE menu, one for standard range fuel tanks, and another for long-range fuel tanks.

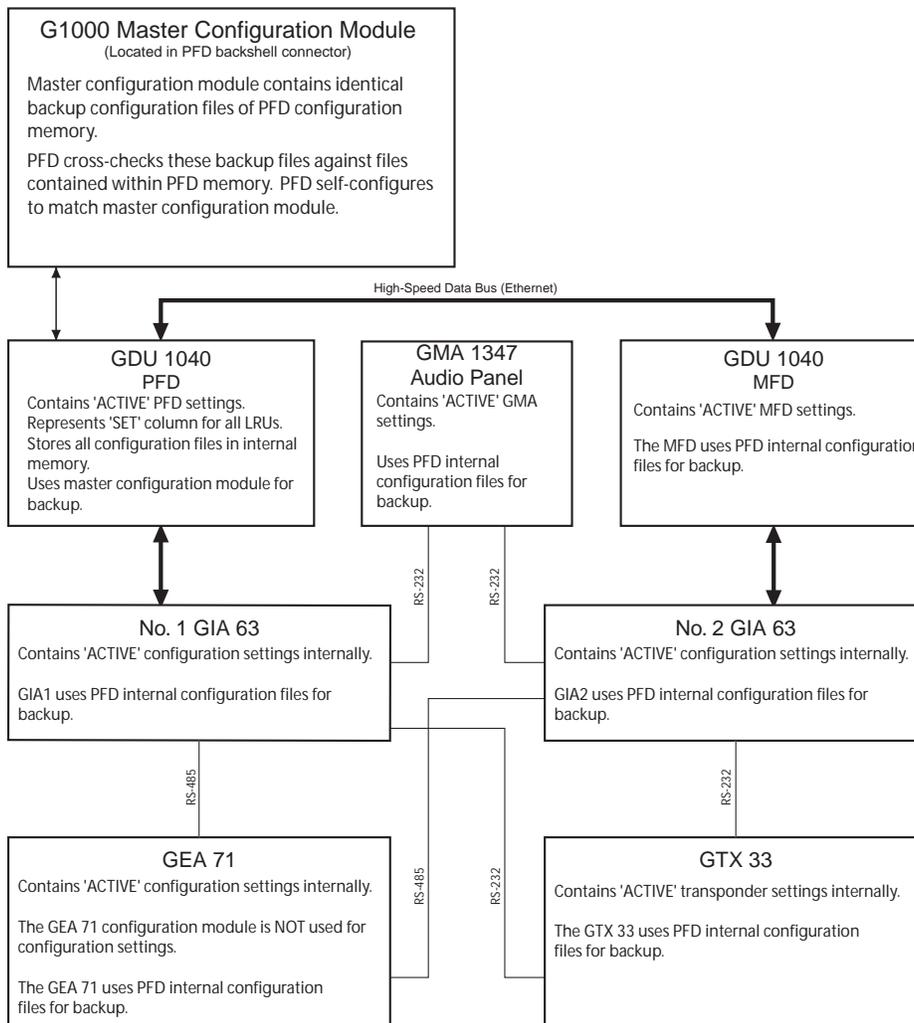
**Figure 3-13. G1000 LRU Configuration File Storage**

During system configuration, each file is sent directly to the applicable LRU where it is stored in local LRU memory (except GRS 77 & GDC 74A). Each file is also stored in PFD internal memory. The PFD also sends a copy of all configuration files to the 'Master Configuration module', located in the connector backshell (see Section 6.13). If the PFD is replaced, the configuration module retains all configuration files in the aircraft.

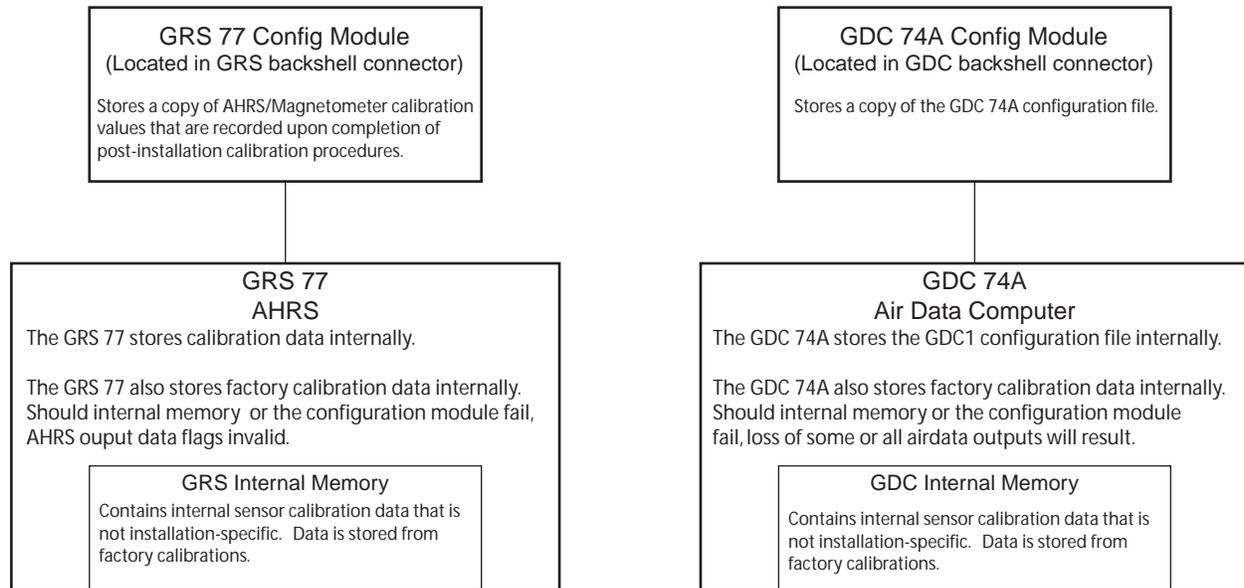
**Figure 3-14. GRS/GDC Configuration Settings Storage**

The GRS 77 and GDC 74A configuration modules function differently than the rest of the system. The GDC 74A's configuration file is loaded directly to GDC internal memory. A copy of the file is stored in the GDC configuration module.

The GRS 77 configuration module does not store any configuration settings. Instead, it stores calibration data recorded during installation calibration procedures.

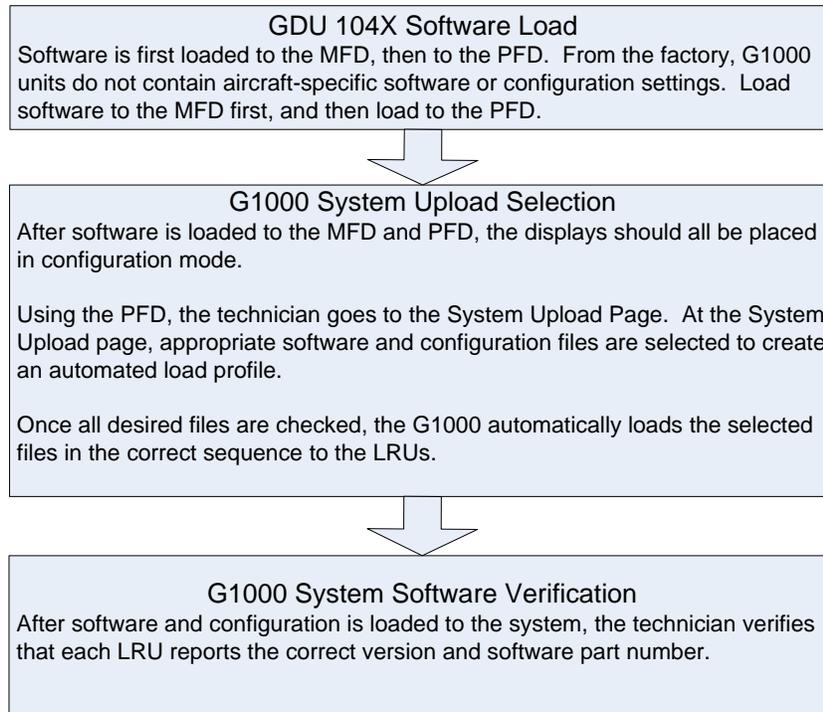
**Figure 3-15. Software/Configuration Overview**

The following diagram depicts an overview of the software/configuration sequence for the G1000 system. This applies mostly to a new G1000 system which has not previously been powered up and is for informative purposes only.

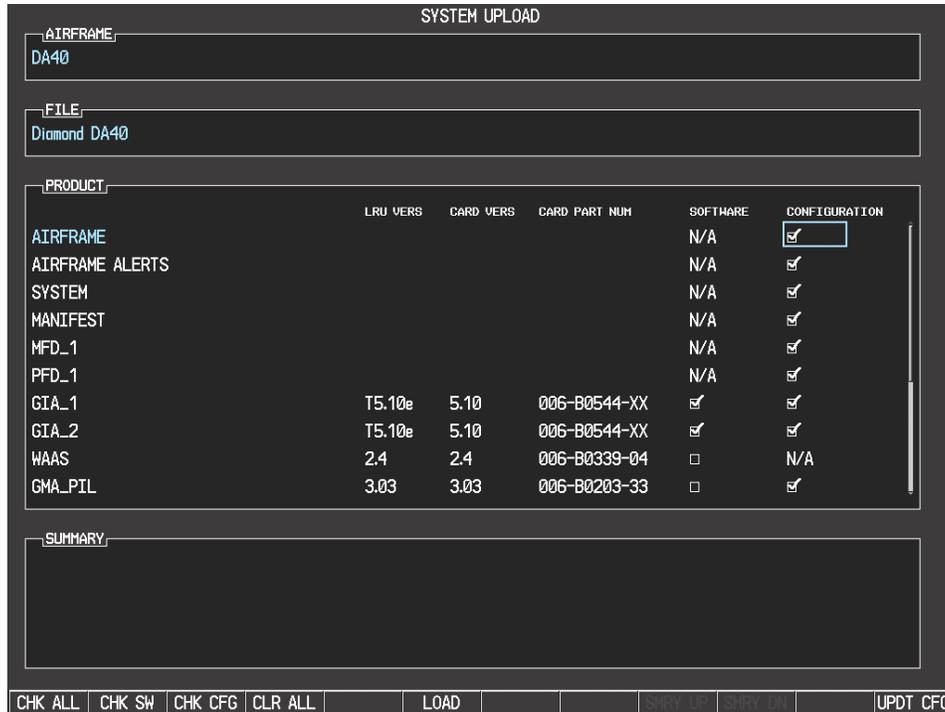
1. With the G1000 powered on in configuration mode, go to the SYSTEM – SYSTEM UPLOAD page on the PFD, as shown:

2. Press the UPDT CFG softkey, located in the lower right corner of the System Upload page.
3. A prompt will appear: “Update Config Module?”
4. Select YES and press the ENT key on the PFD.
5. The system will update the configuration module located in the PFD connector and prompt the technician when successfully complete. Press the ENT key to acknowledge the prompt.
6. Continue to the MFD Splash Screen loading procedure.

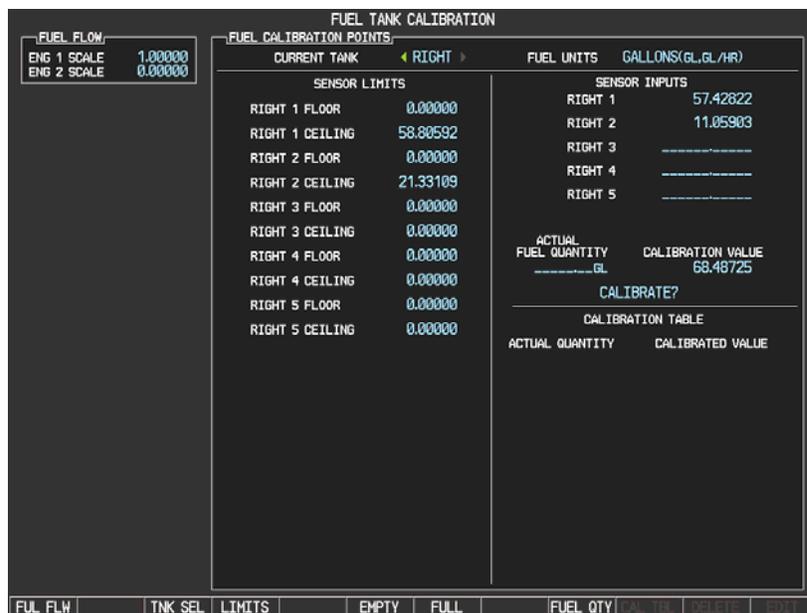
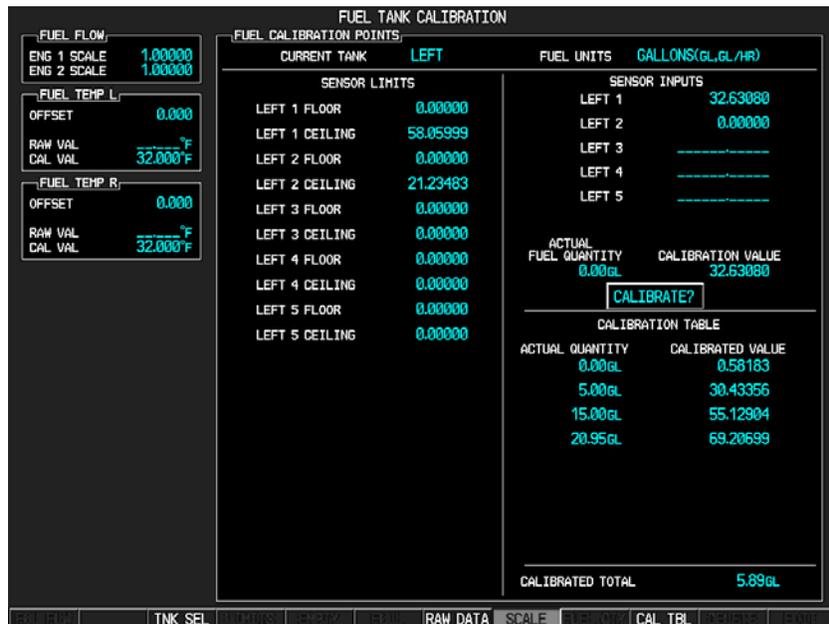
10. Verify the file loads successfully and press the ENT key to acknowledge the confirmation prompt.
11. Restart the MFD in normal mode by pulling and then resetting the MFD circuit breaker.
12. On the MFD, press the ENGINE softkey to display the full page engine instrumentation.
13. Go to the CAL Page Group on the PFD. The FUEL TANK CALIBRATION page should be displayed as shown:

(SW v0321.19 or earlier)

(SW v0321.22)

14. This page is protected and requires a keystroke password to perform the calibration. Press the following softkeys in sequence:

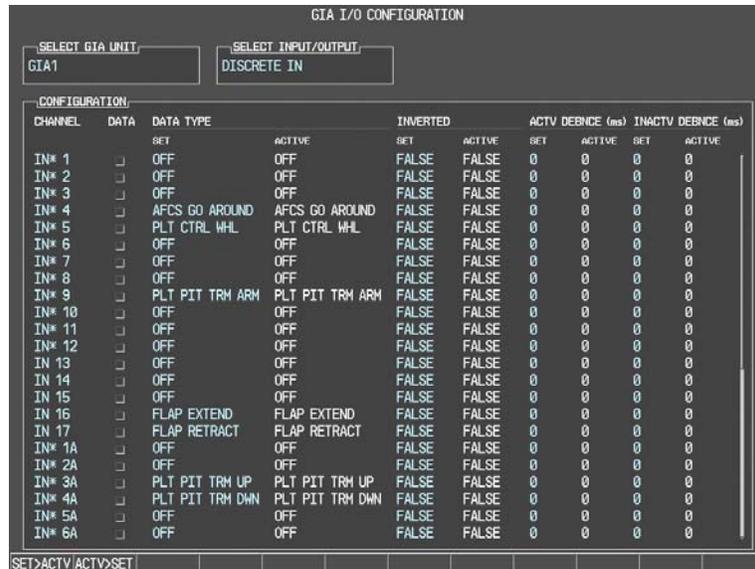
## 4.9 (SW v0321.19 or earlier) Flap Position Discrete Input Check

To perform this check, all G1000 and GFC 700 equipment must be installed and operational. Start the G1000 system in Configuration Mode and go to the GIA Page Group and select the GIA I/O Configuration Page using the FMS knob. Perform the following checks:

The screenshot shows the GIA I/O CONFIGURATION page with the following data:

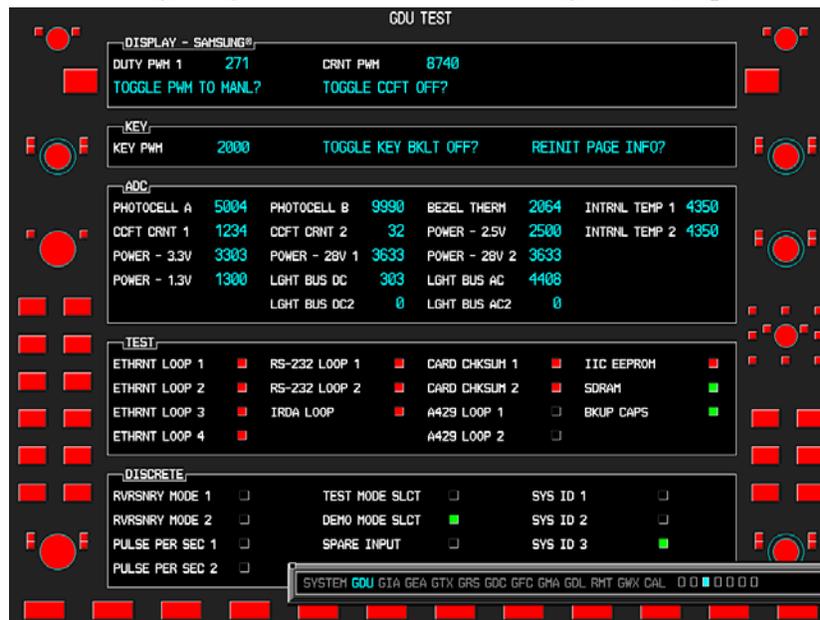
**Figure 4-4. GDU TEST Page**

- a) If display meets or exceeds the minimum MOD status required as specified in Table 4-3, then no further action is required. Reinstall the display according to Section 6.1.
  - b) If one or both displays do not meet the specified MOD status, then the following procedure must be performed.
3. Verify the ambient air temperature is at least 70° Fahrenheit. Apply power to both displays and leave them on for a minimum of 11 minutes.
  4. Remove power from both displays. Place both displays in Configuration mode by holding the ENT key while applying power.
  5. Using the FMS knob go to the GDU TEST page (Figure 4-4) on the MFD and PFD (part of the GDU Page Group).
  6. Verify the BKUP CAPS light is green. If the BKUP CAPS light is red, replace the GDU.

20. Using the FMS knob go to the GDU TEST page (Figure 4-5) on the MFD and PFD (part of the GDU Page Group).
21. Verify the BKUP CAPS box is green indicating a passed test. If the BKUP CAPS box is red, replace the GDU.

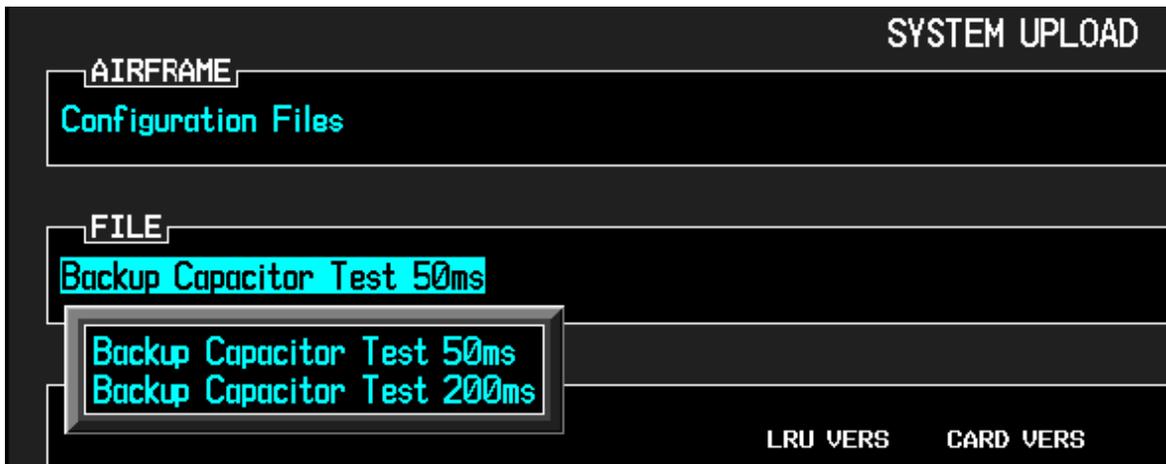
**Figure 4-5. Backup Capacitor Test Selection**

- “Splash Screen File not Found”.
  - “Unknown Configuration for Config Module” – xxxxxxxxxxxx (denotes place holder for the specific configuration listed).
- Press the ENT key at the “DO YOU WANT TO UPDATE SYSTEM FILES?” prompt.
  - Press the ENT key to confirm software update completion.
  - Remove the SD card from the MFD and insert into the top slot of the PFD (leave the MFD on in configuration mode).
  - Power the PFD on in configuration mode by holding down the ENT key while applying power (release the ENT key when the words “INITIALIZING SYSTEM” appear on the display).
  - Press the ENT key at the “DO YOU WANT TO UPDATE SYSTEM FILES?” prompt.
  - Press the ENT key to confirm software update completion.
  - Use the FMS knob to select the SYSTEM UPLOAD Page.
  - Select the configuration file “Backup Capacitor Test 50ms” from the SYSTEM UPLOAD Page (Figure 4-3).

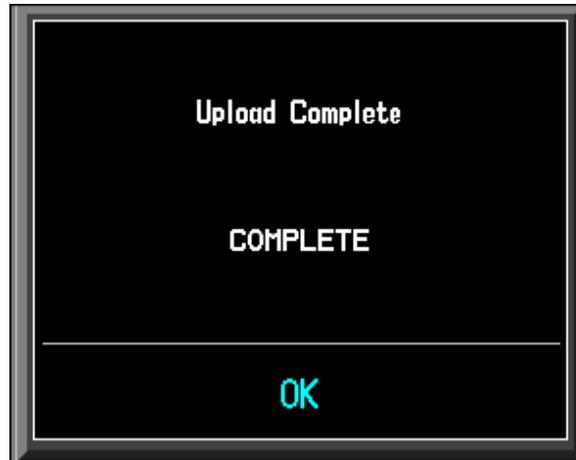
**Figure 4-6. Upload Complete Window**

13. Press the ENT key to confirm the configuration file selection.
14. Press the LOAD softkey to load the configuration file.
15. Press the ENT key to confirm upload completion (Figure 4-4).

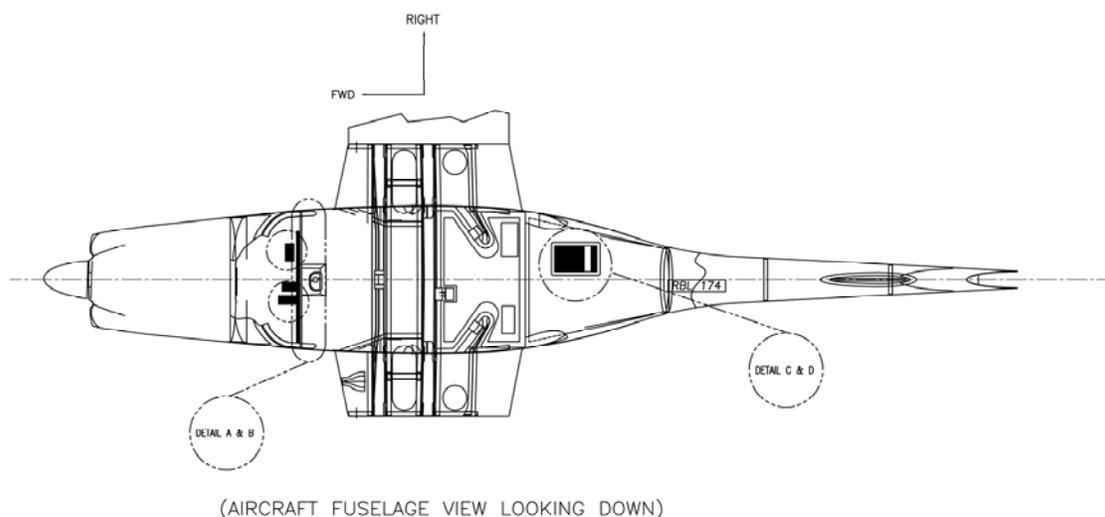
**Figure 4-8. Aircraft Fuselage Fuse Locations**

Every 24 calendar months, replace all lightning protection 3.2 Amp slow-blow fuses. There are five total fuses in the system that is part of this requirement.

Figure 4-8 shows the general location of the fuse locations and provides reference to the applicable detail with in this section that applies.

1. Refer to Figure 4-8, Figure 4-9 and Figure 4-10 to locate the two fuses mounted behind the instrument panel, near the circuit breaker panel. Each fuse is wired inline with a voltage suppressor.
2. Twist each fuse holder cap counter-clockwise, remove each fuse and replace with a new fuse. Reference Table 4-5 for the proper P/N fuse.

1. Refer to Figure 4-8, Figure 4-11 and Figure 4-12 to locate the three fuses which is attached to the forward portion of the remote avionics enclosure. Each fuse is mounted to the side of the block, and each is labeled.
2. Twist each fuse holder cap counter-clockwise, remove each fuse and replace with a new fuse. Reference Table 4-5 for the proper P/N fuse.

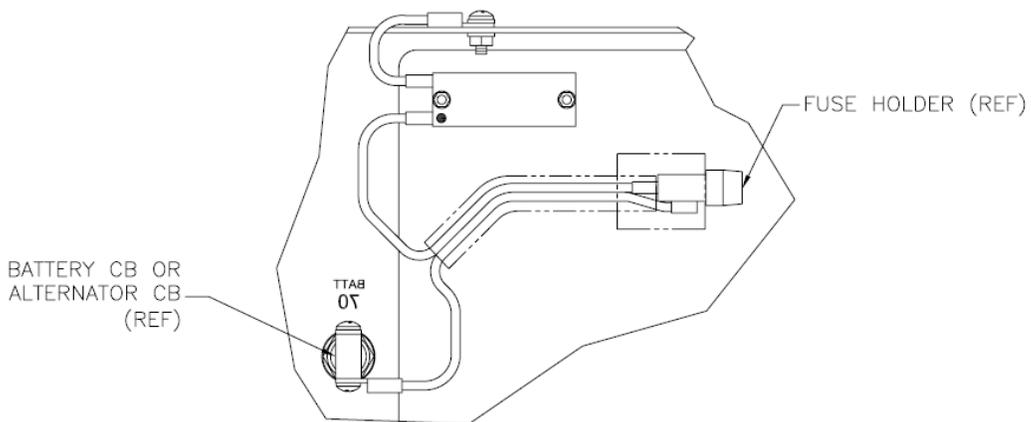
**Figure 4-10. Instrument Panel Detail B**

(BATTERY & ALTERNATOR FUSE HOLDERS)  
DETAIL B

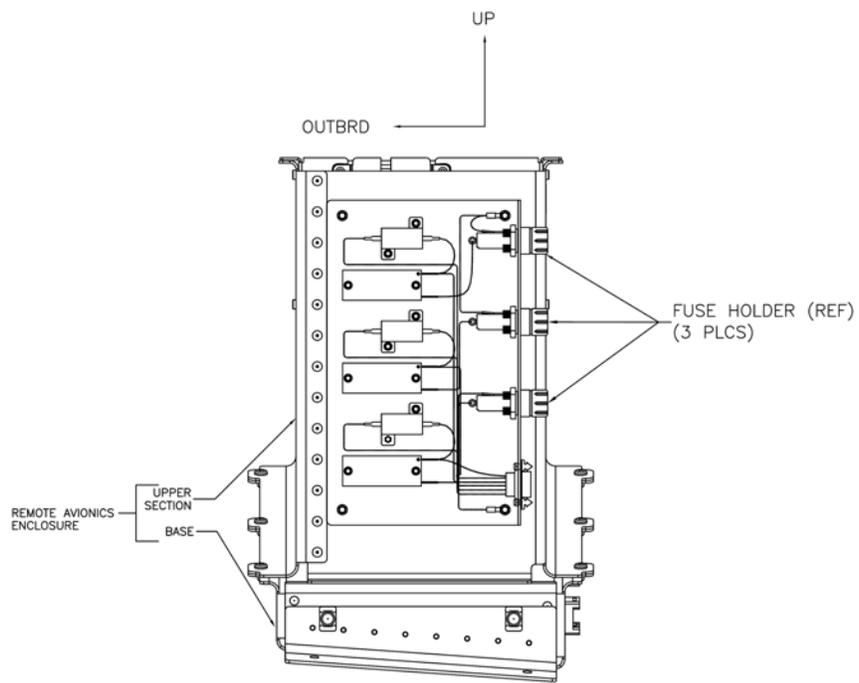
**Figure 4-12. Remote Avionics Enclosure Detail D**

(REMOTE AVIONICS ENCLOSURE)  
VIEW LOOKING AFT  
DETAIL D

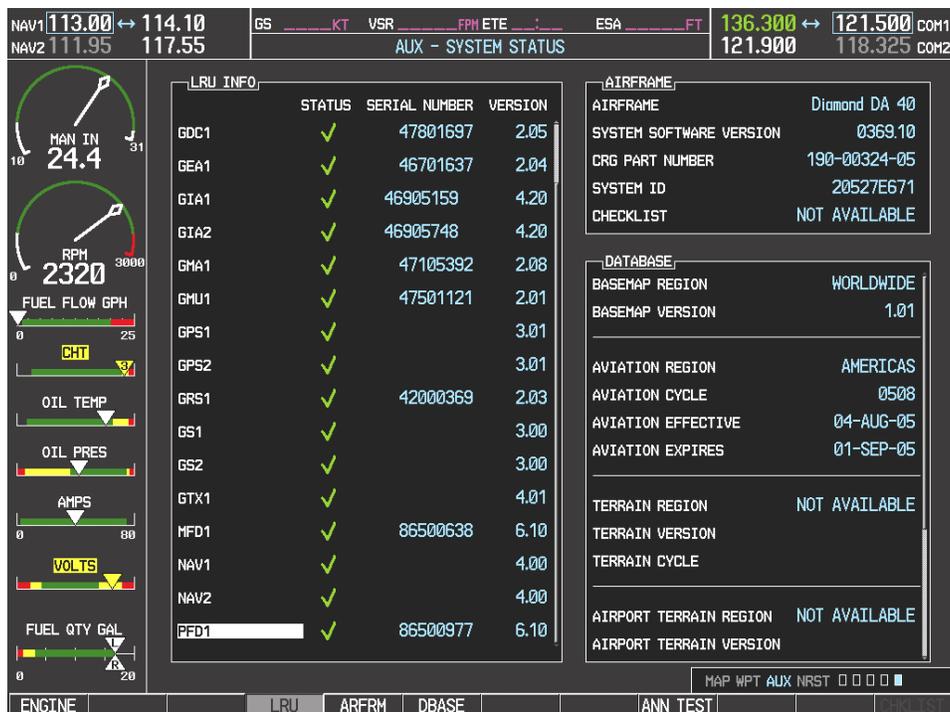
**Figure 5-1. AUX – System Status Page**

The AUX – System Status page is the 5<sup>th</sup> page in the AUX Page Group and displays the following information for each LRU and sub-function:

When troubleshooting, first check to ensure that each LRU status is 'green' and that the correct software is loaded in each unit. Additional airframe and database information is also displayed on this page.

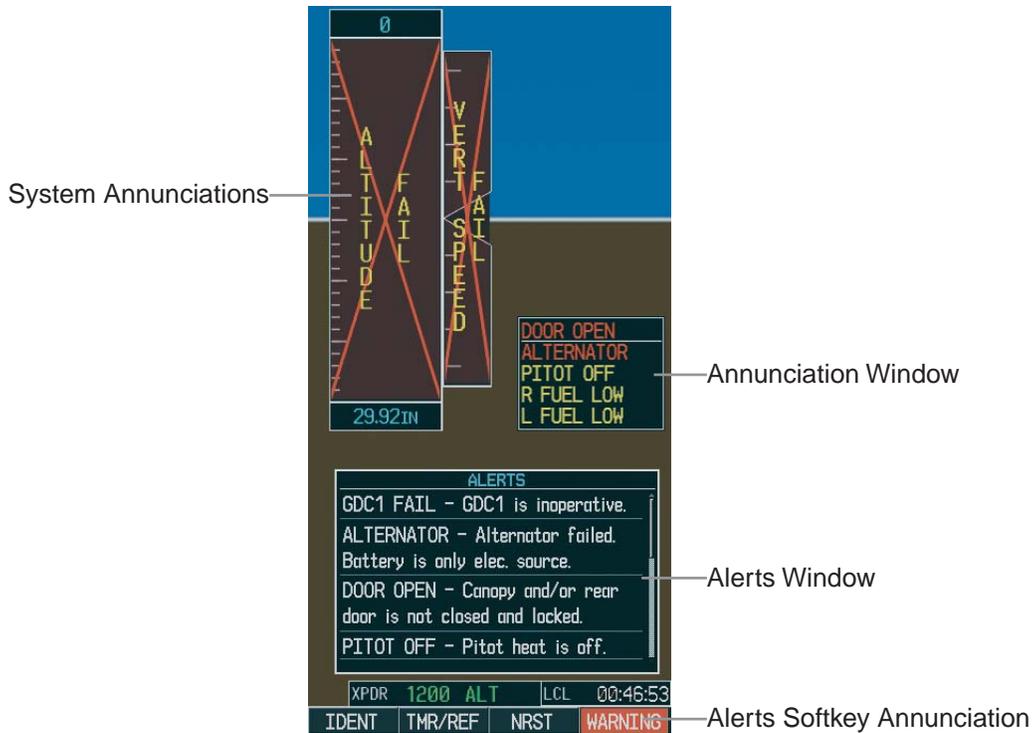
**Figure 5-2. Alerts & Annunciations**

The G1000 Alert System conveys alerts to the pilot using combinations of the following features:

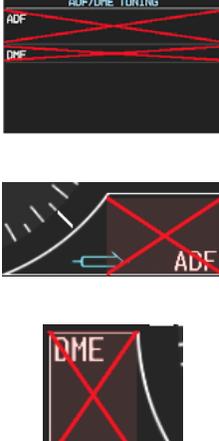
Effective System Software Version 0369.08 or later, an ADF and DME interface were added as an option. The PFD functions as a control head for the remote-mounted Becker ADF and Honeywell DME. A DME or ADF failure is represented by the following red X's.

<p>Becker ADF and Honeywell DME</p>	<p>Ensure that GIA 63 #2 is properly functioning.</p> <p>Reload the ADF or DME option configurations.</p> <p>Check for proper operation of the ADF or DME receivers. Ensure that each is receiving power.</p> <p>Check ADF – GIA2 and DME – GIA2 interconnect. Refer to Diamond wiring diagram for details.</p> <p>Replace ADF or DME unit(s).</p>
--	-------------------------------------	--

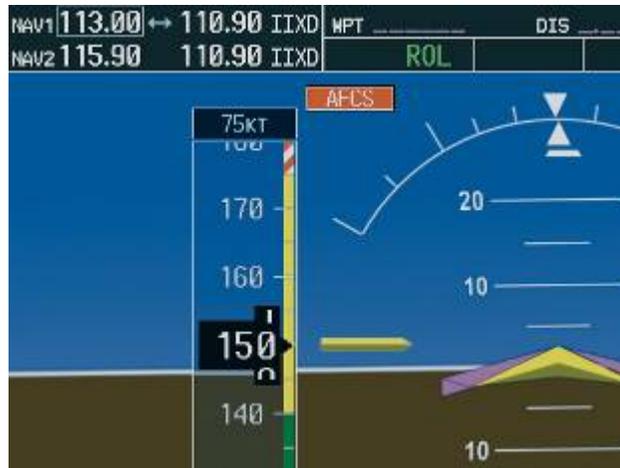
**Figure 5-7. AFCS Annunciation Field**

The GFC 700 AFCS Annunciation field is located above the airspeed tape on the PFD as shown:

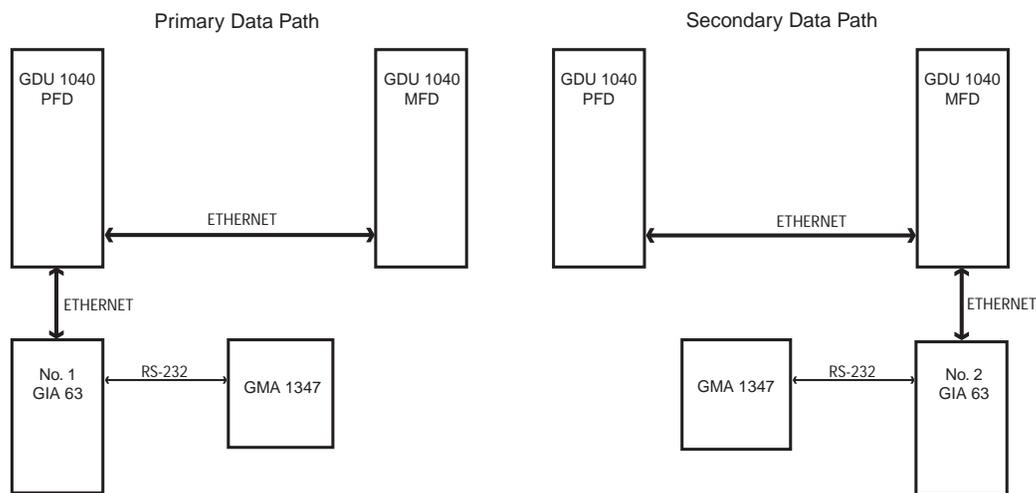
**Figure 5-8. GMA 1347 Data Paths**

The GMA 1347 utilizes two backup paths to preserve communications with the G1000. The primary data path is from the GMA1 through GIA1 to the PFD. The secondary backup path is through GIA2 into the MFD. Audio panel data is cross-filled to the appropriate display over the HSDB.

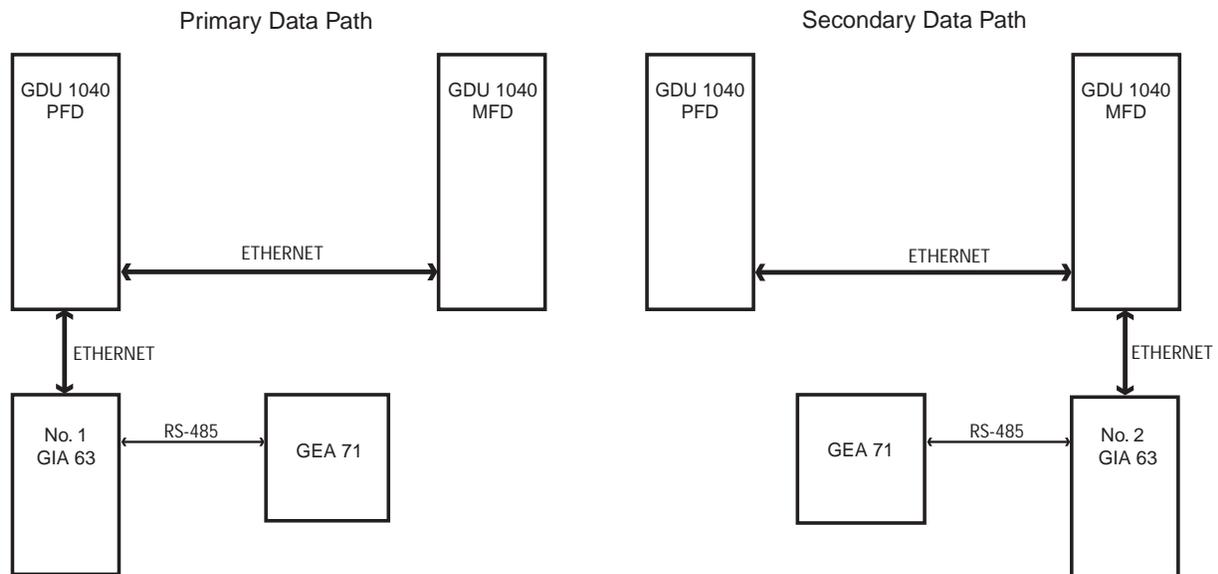
**Figure 5-9. GEA 71 Data Paths**

The GEA 71 Engine/Airframe Unit utilizes two backup paths to preserve communications with the G1000. The primary data path is from the GEA through GIA1 to the PFD, where it is then cross-filled to the MFD. The secondary backup path is through GIA2 into the MFD.

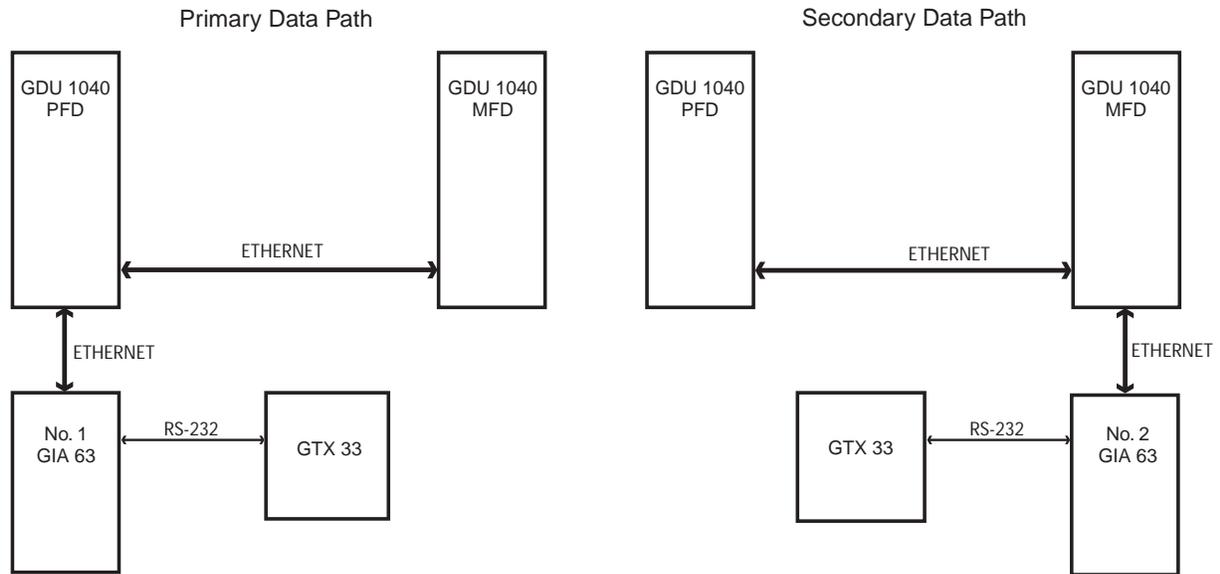
**Figure 5-10. GTX 33 Data Paths**

The GTX 33 transponder utilizes two backup paths to preserve communications with the G1000. The primary data path is from the GTX 33 through GIA1 to the PFD. The secondary backup path is through GIA2 into the MFD. Transponder data is cross-filled to the appropriate display over the HSDB.

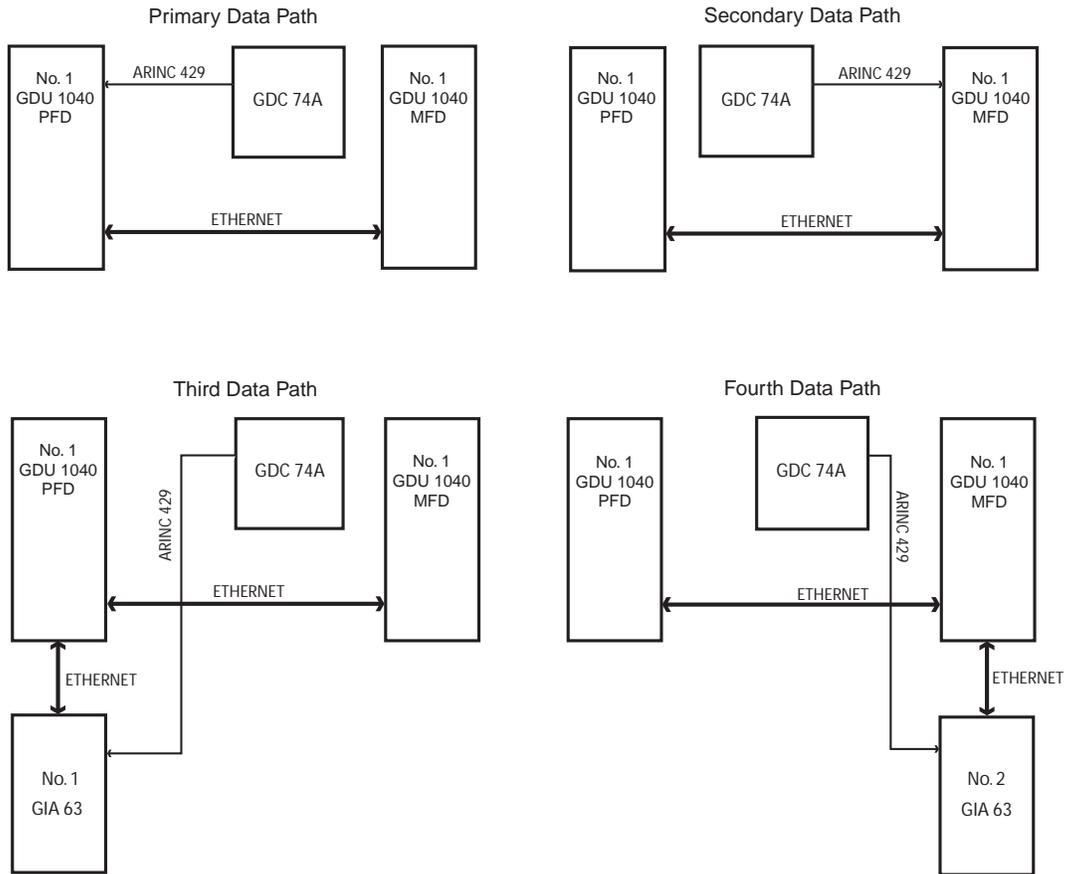
**Figure 5-11. GDC 74A Data Paths**

The GDC 74A Air Data Computer has 4 redundant communication paths which are capable of supplying ARINC 429 air data information to the PFD and MFD. The primary path is the ARINC 429 bus between the GDC 74A and the PFD. The secondary backup path is the ARINC 429 bus input to the MFD. The tertiary backup path inputs ARINC data to GIA1, where it is then sent over HSDB to the PFD. The last backup path inputs ARINC data to GIA2, where it is then sent over HSDB to the MFD. The air data is then cross-filled to the appropriate display.

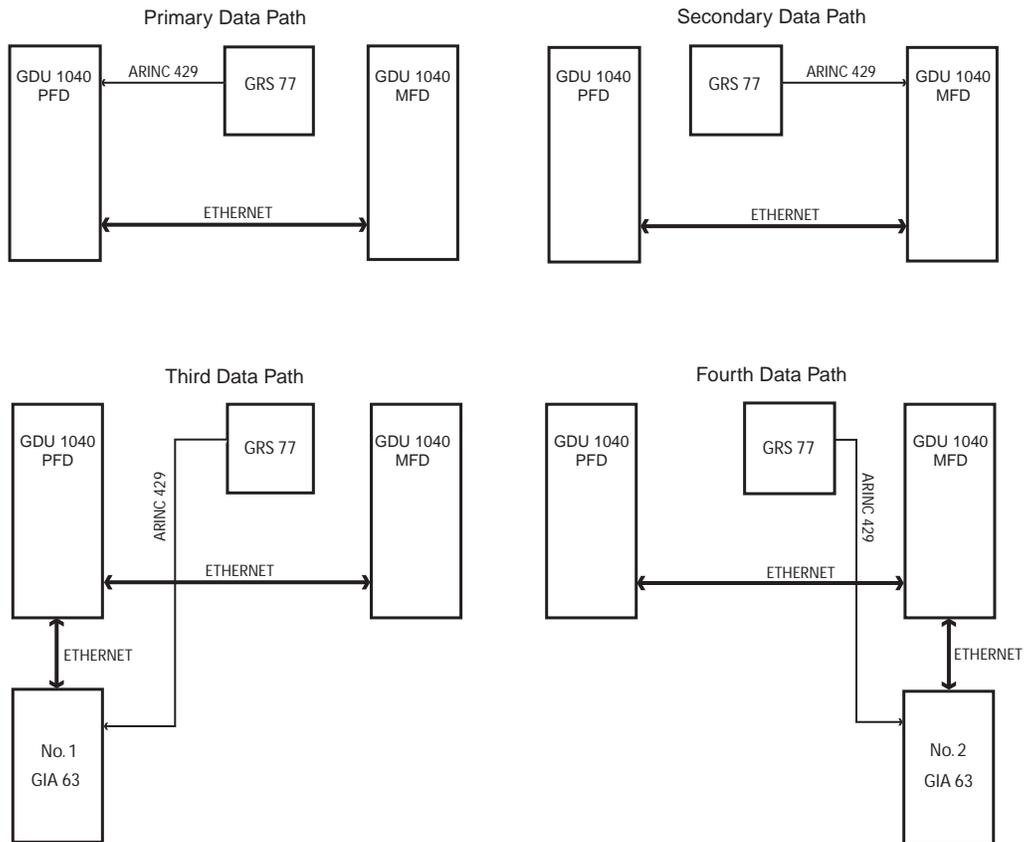
**Figure 5-12. GRS 77 Data Paths**

The GRS 77 AHRS has 4 redundant communication paths which are capable of supplying ARINC 429 attitude and heading information to the PFD and MFD. The primary path is the ARINC 429 bus between the GRS 77 and the PFD. The secondary backup path is the ARINC 429 bus input to the MFD. The tertiary backup path inputs ARINC data to GIA1, where it is then sent over HSDB to the PFD. The last backup path inputs ARINC data to GIA2, where it is then sent over HSDB to the MFD. AHRS data is then cross-filled to the appropriate display.

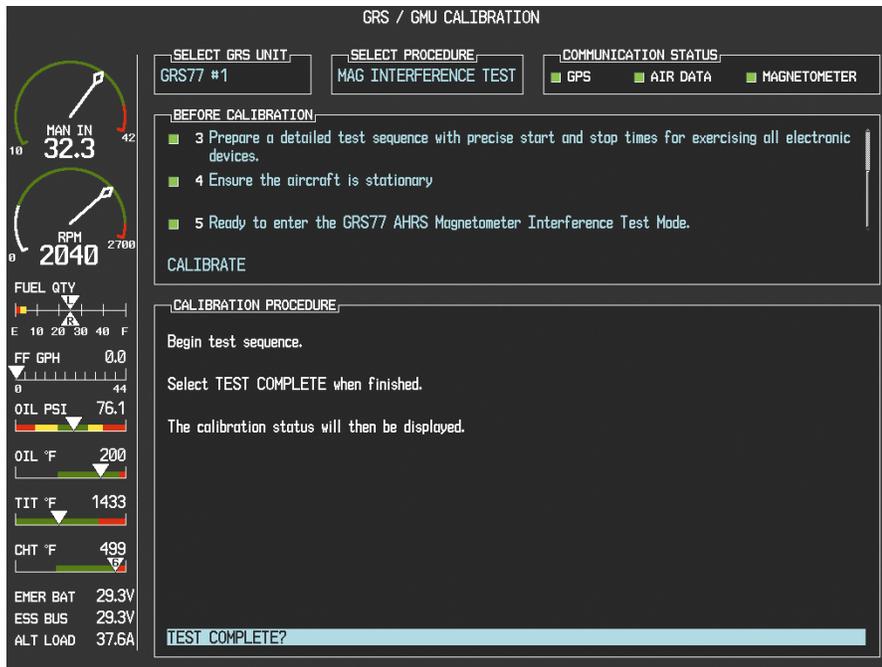
Figure 5-13. (SW v0321.19 or earlier) Magnetometer Interference Test

This test is optional and is used to validate that no electronic device interferes with the operation of the GMU 44 magnetometer. It is highly recommended that this test be performed after installation or maintenance of electrical components on the aircraft and/or for troubleshooting the GMU 44.

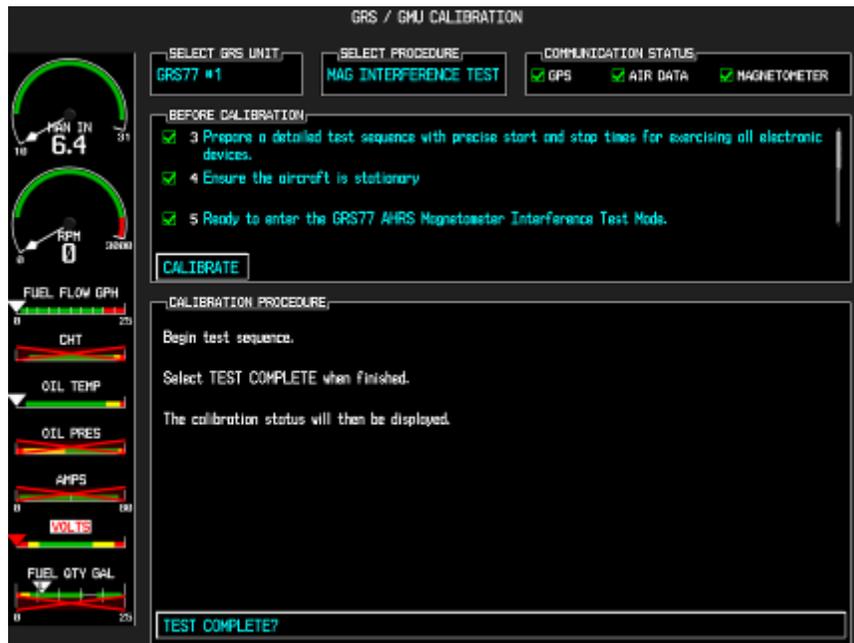
**Figure 5-14. (SW v0321.22) Magnetometer Interference Test**

1. Initiate the AHRS magnetometer interference test procedure by performing the following steps:
2. Enter Configuration Mode and go to GRS/GMU Calibration page as shown in Figure 5-14.
3. This page is protected and requires a keystroke password to perform this test. Press the following softkeys in sequence:
  - i) softkey 9
  - ii) softkey 10
  - iii) softkey 11
  - iv) softkey 12
4. Select MAG INTERFERENCE TEST and press the ENT key.
5. Follow the checklist items displayed on the PFD, and press the ENT key as each one is completed or confirmed.
