# G1000 System Maintenance Manual

## Diamond DA 40 & DA 40 F With GFC 700 or KAP 140 AFCS

Contains FAA-Accepted Instructions  
For Continued Airworthiness For  
STC SA01444WI-D

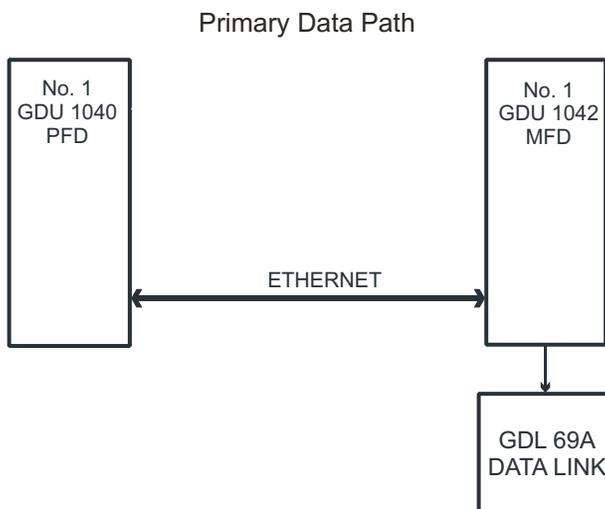
**Figure 5-15. GDL 69A Data Paths**

Failure Message	Cause	Solutions
MANIFEST – GDL software mismatch. Communication Halted.	The system has detected an incorrect software version loaded in GDL 69A.	Load correct software version. See Section 3.6 for the software load procedure.
GDL69 CONFIG - GDL 69 config error. Config service req'd.	The system has detected a GDL 69A configuration mismatch.	Reload configuration. See Section 3.6 for the configuration procedure.
GDL69 FAIL - GDL 69 has failed.	The system has detected a failure in the GDL 69A.	Ensure GDL 69 is receiving power.  Check wiring from GDL 69A to MFD.  Replace GDL 69A if problem persists.

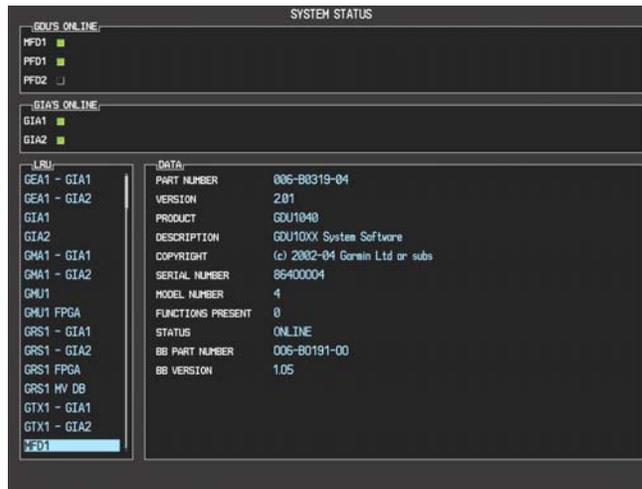
**Figure 6-1. (SW v0321.19 or earlier)  
System Status Page (Configuration Mode)**

1. Start the G1000 system in configuration mode as described in Section 3.4.

2. The System Status page shows a list of LRUs in the LRU window. Activate the cursor and use the FMS knob to scroll through the list in the window and select the following items:

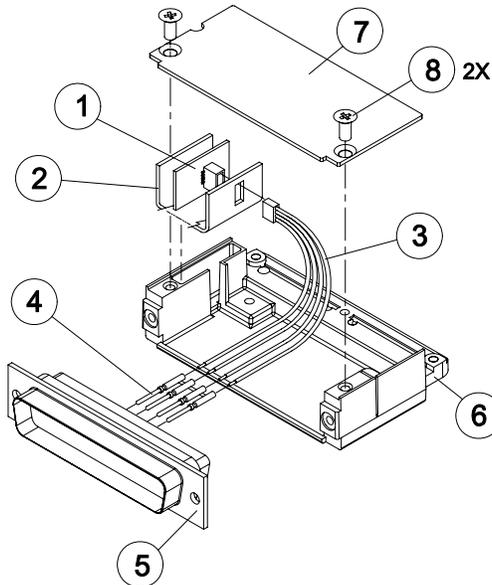
**Figure 6-3. Configuration Module Installation**

If the master configuration module is replaced, the G1000 system ID number will change. You may need to replace the Terrain, TAWS unlock, Chartview/Jeppview/FlightCharts and other SD cards since they will be locked to the old system ID number. Contact Garmin for assistance in determining which cards will need to be replaced.

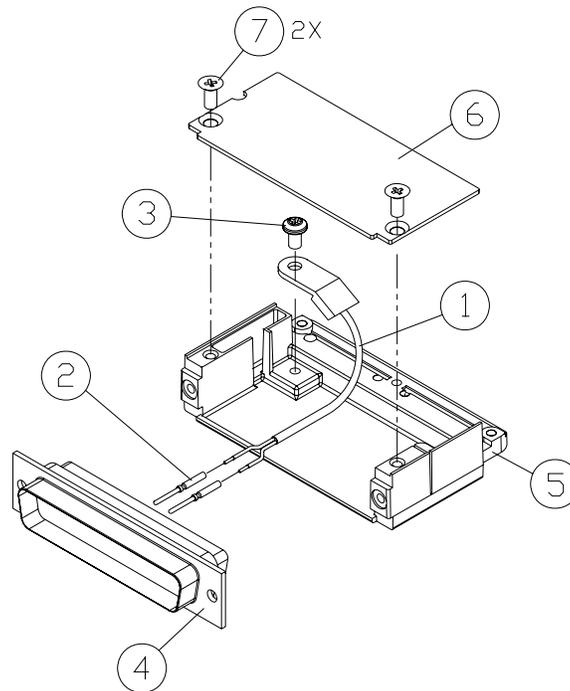
Figure 6-4. GEA Backshell Thermocouple

The GEA 71 has a K-Type thermocouple (Item 1 shown below) installed in its backshell, in addition to the configuration module. The thermocouple is used in conjunction with the configuration module temperature sensor to compensate for EGT/CHT temperature probe errors resulting from the dissimilar metals at the pin contacts.

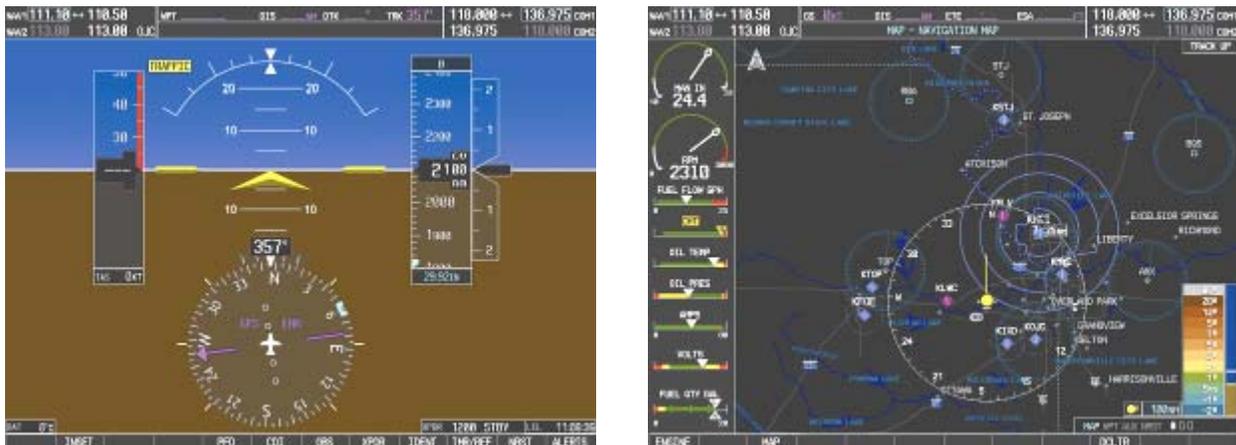
**Figure 7-1. G1000 Normal Mode Check**

*For PFD:* Check that attitude, heading, altitude, airspeed, vertical speed and OAT fields are valid within 2 minutes of power up.

*For MFD:* Check that the engine instrument fields are valid.

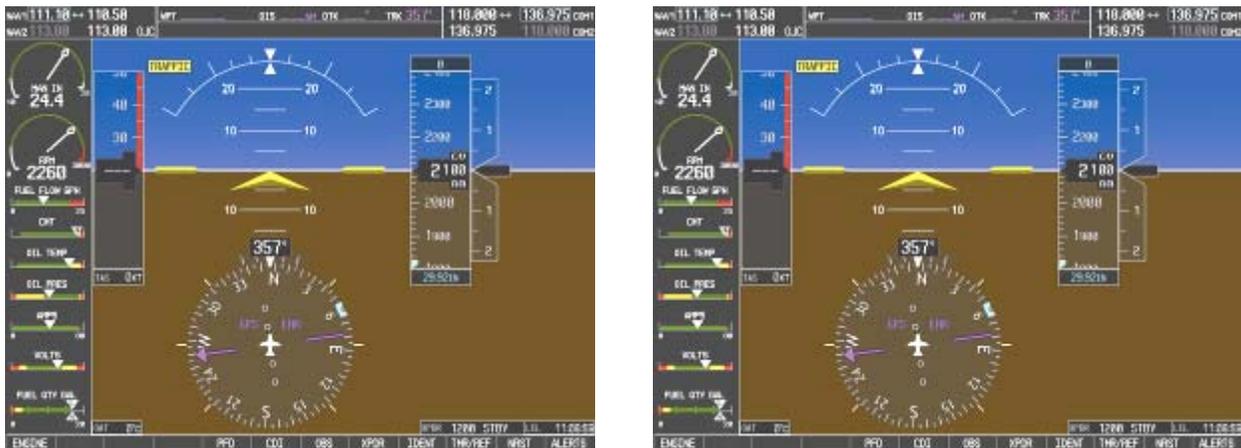
**Figure 7-2. G1000 Reversionary Mode Check**

3. Push the red DISPLAY BACKUP button on the GMA 1347. Verify both displays enter reversionary mode (both should have valid attitude, heading, altitude, airspeed, vertical speed, and engine instruments):

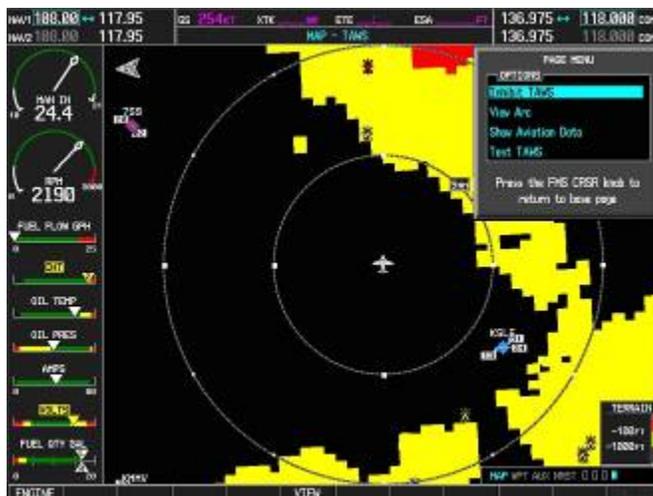
4. De-activate reversion mode by pushing the red DISPLAY BACKUP button again.
5. If TAWS was activated, select the TAWS page (4th page in the MAP group) on the MFD.

- a. Verify that the title at the top of the page reads “MAP – TAWS”. If TAWS has not been enabled, the title will read “MAP – TERRAIN PROXIMITY” or “MAP – TERRAIN”.
  - b. Press the MENU button and select “Test TAWS” from the pop-up menu.
  - c. After the TAWS test has completed, verify that “TAWS System Test Okay” is heard over the cockpit speaker.
6. If no other service is to be performed, perform final return-to-service test as specified in Section 8.

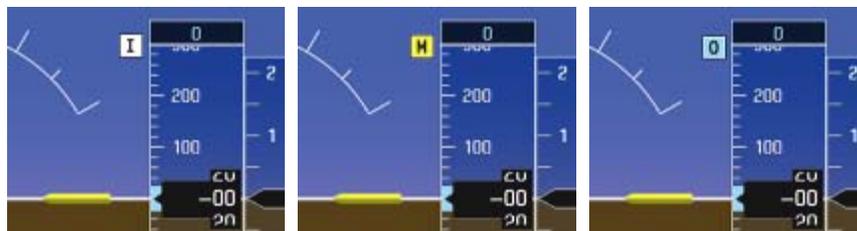
Figure 7-3. Marker Beacon Symbology

Verify that the outer, middle, and inner annunciations appear on the PFD when the corresponding signal is applied. Marker beacon annunciations appear at the upper left corner of the altitude indicator on the PFD (Figure 7-3). Operate the MKR MUTE key on the GMA 1347 and ensure that the audio signal is muted.

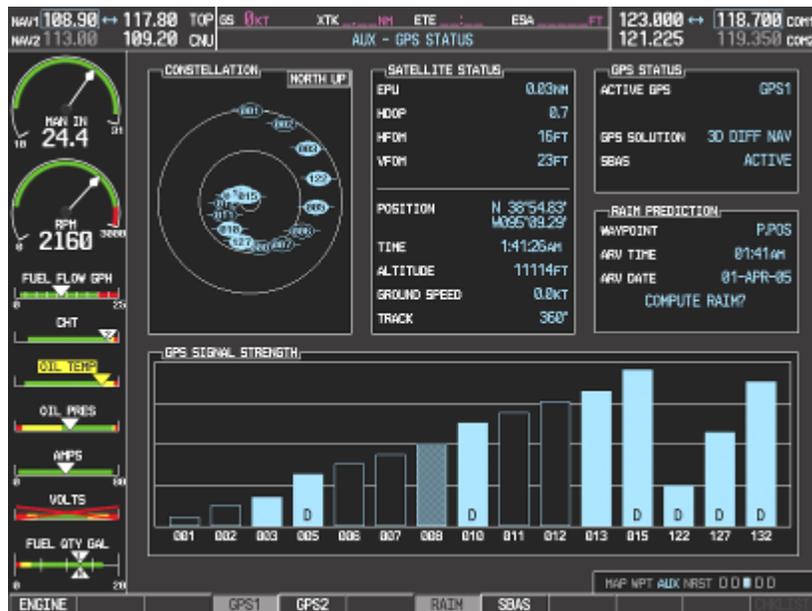
**Figure 7-4. AUX – GPS STATUS Page (MFD)**

The GIA 63(W) units should normally acquire a GPS navigation solution within 5 to 10 minutes of startup, provided the aircraft is outside (or indoors with a GPS repeater). Select the GPS STATUS page on the MFD (3<sup>rd</sup> page in AUX group). Two softkeys on the bottom of the display allow the user to toggle between GPS 1 and GPS 2.

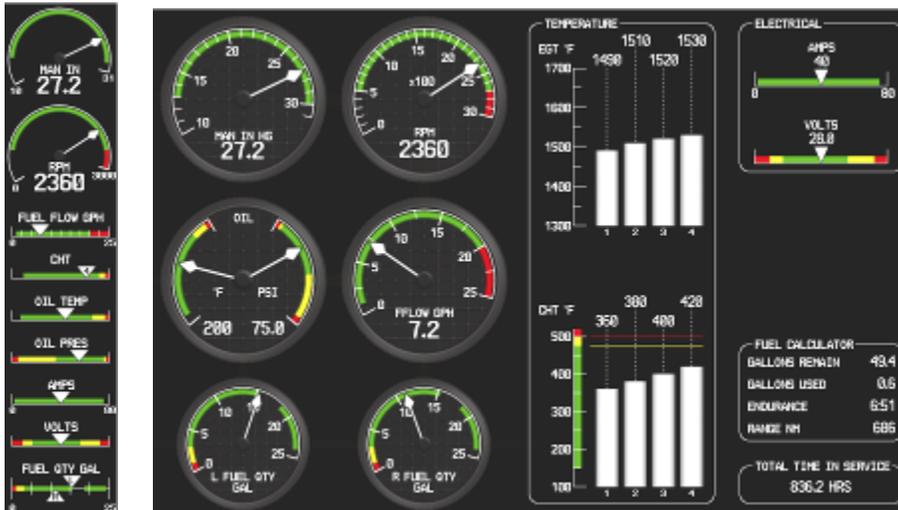
1. Observe the EIS strip on the MFD and check each display gauge value against.
2. Press the ENGINE softkey and observe the full-page EIS display. Check each display gauge value against Table 7-1.

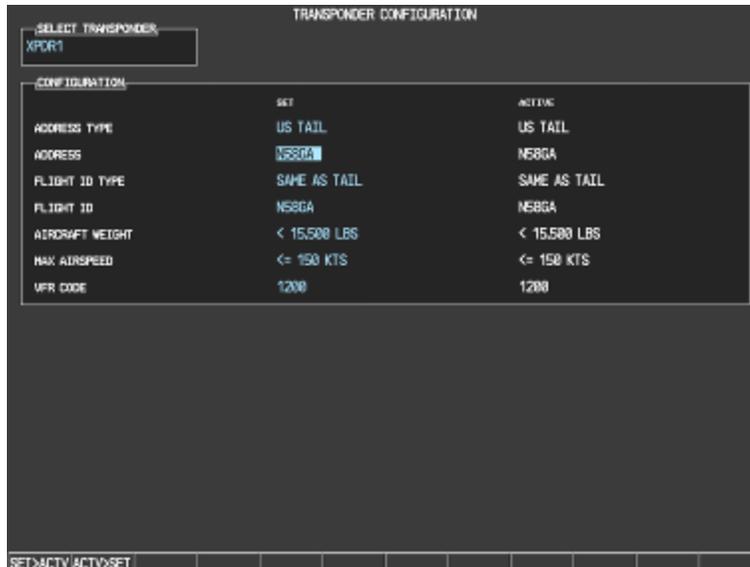
Select the GTX page group, then select the Transponder Configuration page on the PFD:

1. Ensure that the 'ADDRESS TYPE' is 'US TAIL' under the 'SET' and 'ACTIVE' columns.
2. Activate the cursor and highlight the 'ADDRESS' field. Use the small/large FMS knobs to enter the aircraft registration number.
3. Once the correct registration number is entered, press the ENTER key. The transponder is configured:

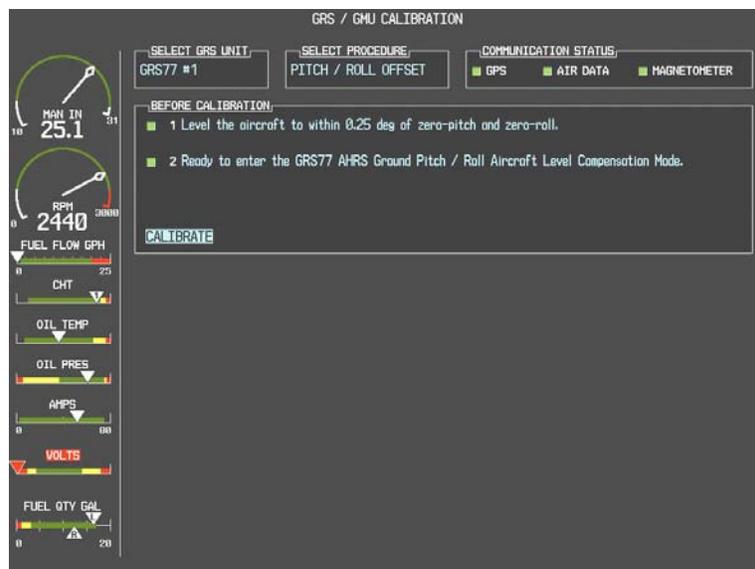
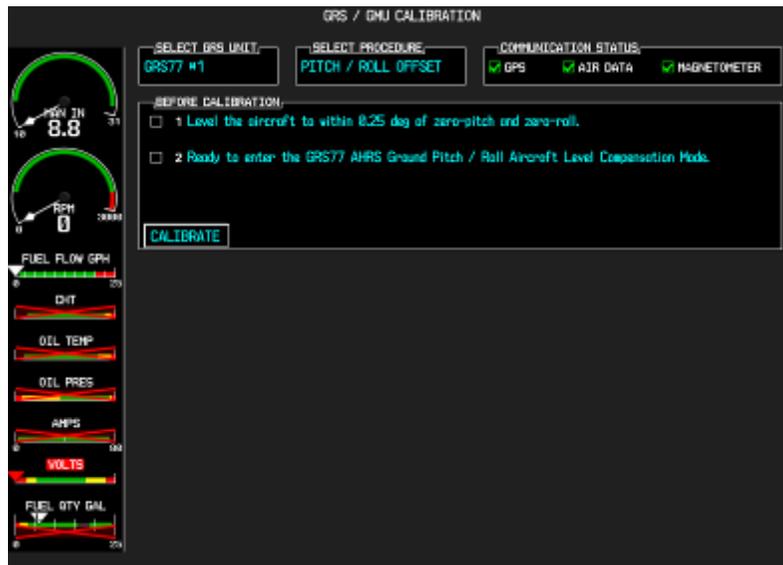
1. Level the aircraft to within  $\pm 0.25^\circ$  of zero pitch and zero roll using a digital level. (Follow instructions in DA 40 Aircraft Maintenance Manual for leveling)
2. Start the G1000 system in Configuration mode.
3. Go to the GRS Page Group and select the GRS/GMU Calibration page at the PFD. This page is protected and the following softkey password must be entered at the PFD to continue:
  - a) 9
  - b) 10
  - c) 11
  - d) 12 (Far Right softkey)

4. Ensure that the No. 1 GRS 77 is selected in the SELECT GRS UNIT window on the PFD.
  - a) Activate the cursor and highlight the SELECT PROCEDURE window and select PITCH/ROLL OFFSET.

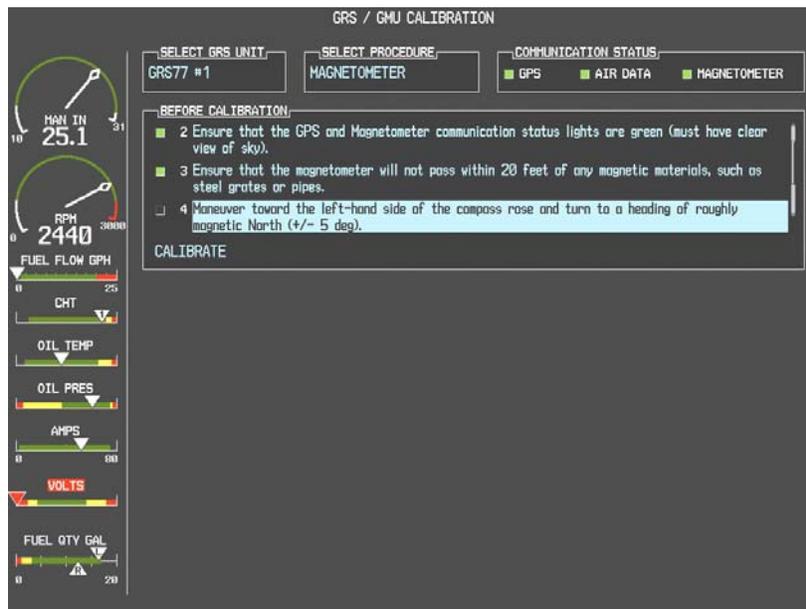
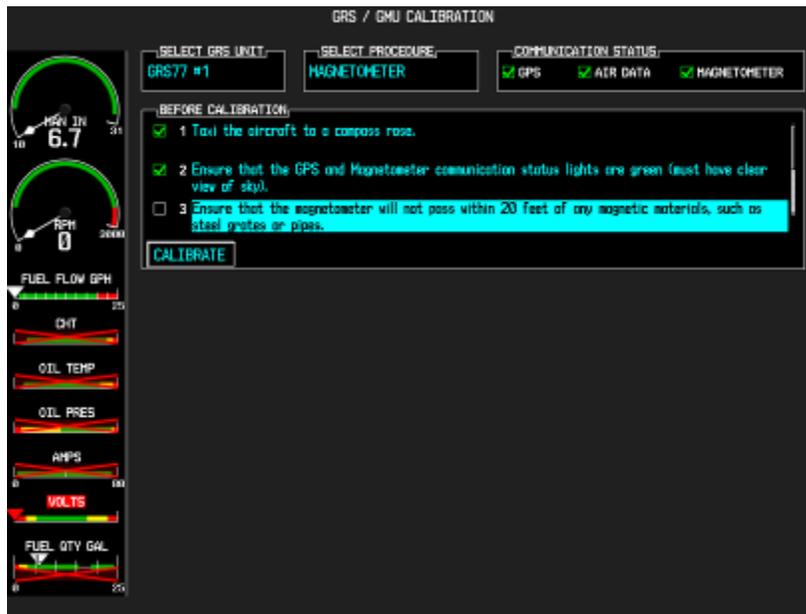
4. Restart the PFD and MFD in configuration mode.
5. Go to the GRS Page Group on the PFD.

6. Select the GRS/GMU Calibration page and enter the following softkey password:
  - a) 9
  - b) 10
  - c) 11
  - d) 12 (Far Right softkey)

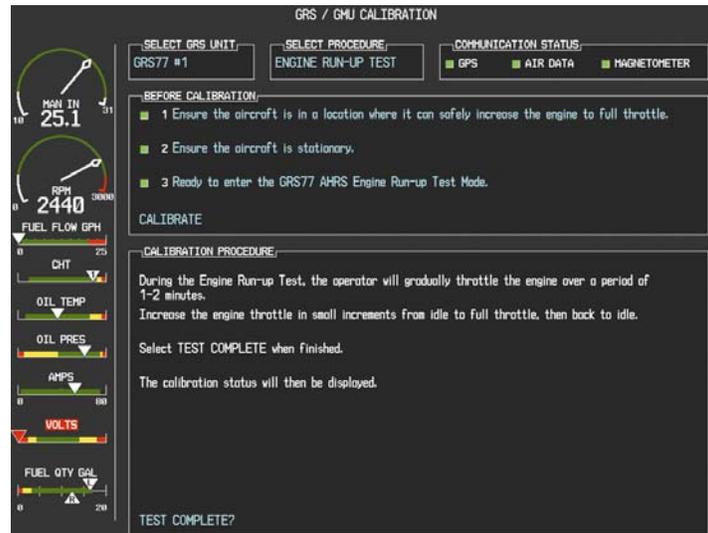
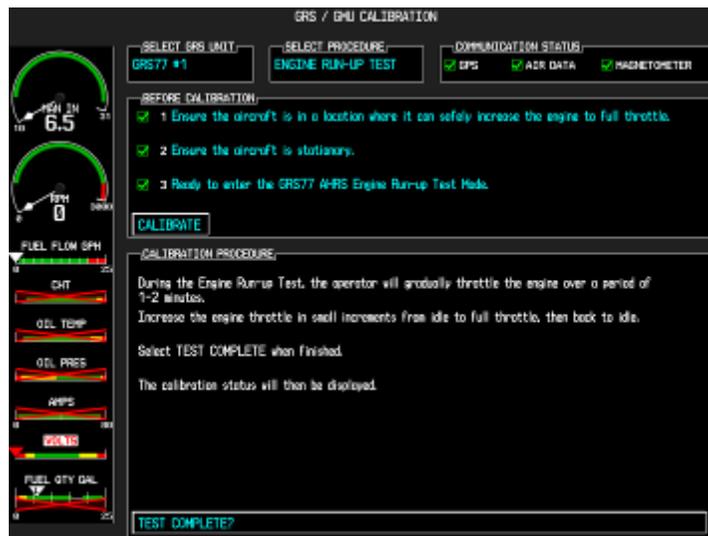
Calibration Procedure D must be performed in order to guarantee that the AHRS mounting is sufficiently rigid and insensitive to vibration.

1. Initiate the AHRS engine run-up vibration test procedure by performing the following steps:
  - a) Select the ENGINE RUN-UP TEST procedure and press the ENT key.
  - b) Follow the checklist items displayed on the PFD, and press the ENT key as each one is completed or confirmed. When the CALIBRATE field is blinking, press the ENT key to begin the procedure.
2. The PFD display instructs the operator to gradually increase power from idle to full throttle and back to idle over a period of 2-4 minutes.

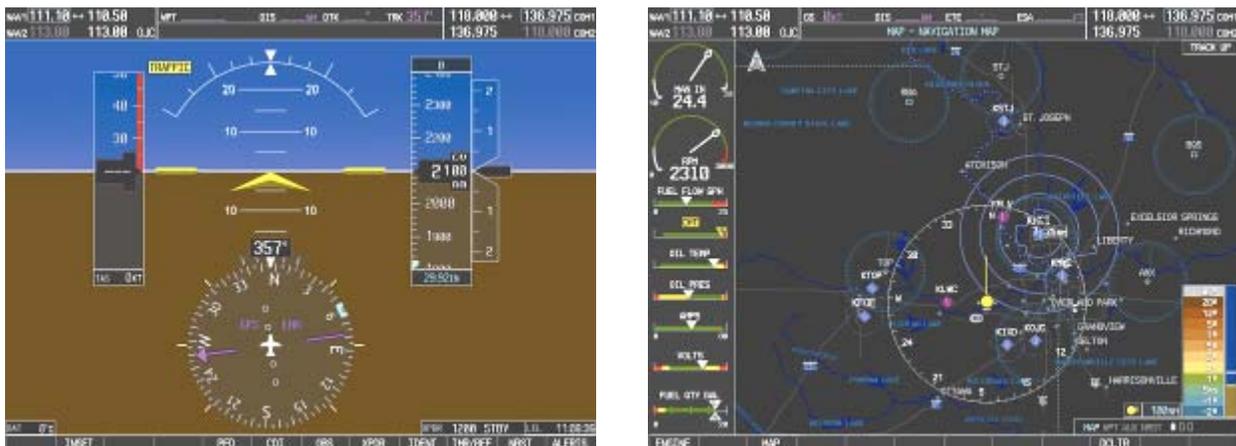
**Figure 7-5. Normal Mode AHRS Check**

The aircraft can now be taxied back and the engine can be shut down for final testing. Restart both displays in normal mode to conduct final system checks. When the PFD powers up in normal mode, the AHRS attitude and heading information displayed should become valid within 1 minute of power-up, as shown in Figure 7-5 (provided both GPS receivers have a valid position; if GPS is unavailable, AHRS initialization may take as long as 2 minutes).

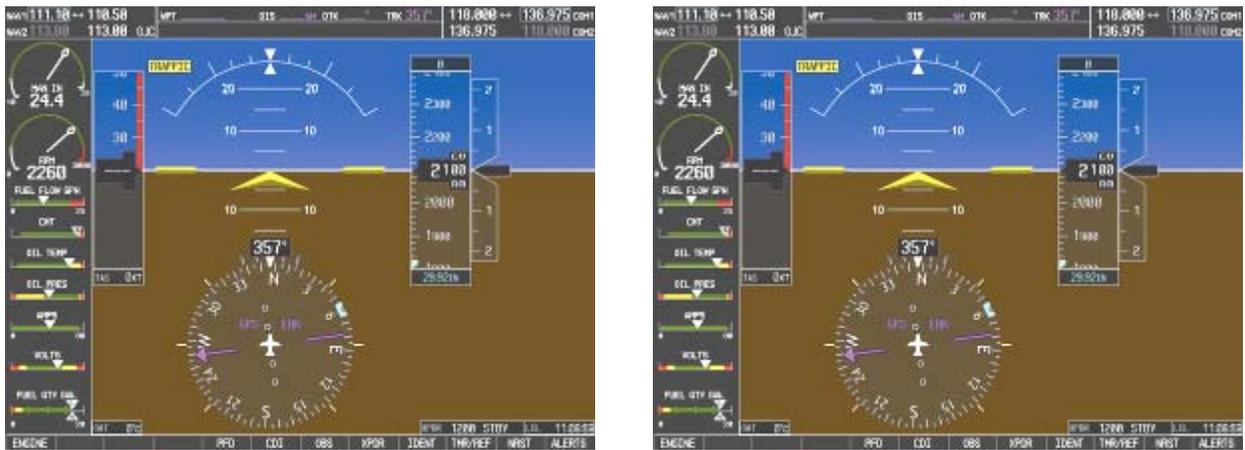
**Figure 7-6. Reversionary Mode AHRS Information**

Test the AHRS reversionary paths by pressing the red reversionary mode button on the audio panel. Ensure that both displays have valid AHRS information, as shown in Figure 7-6.

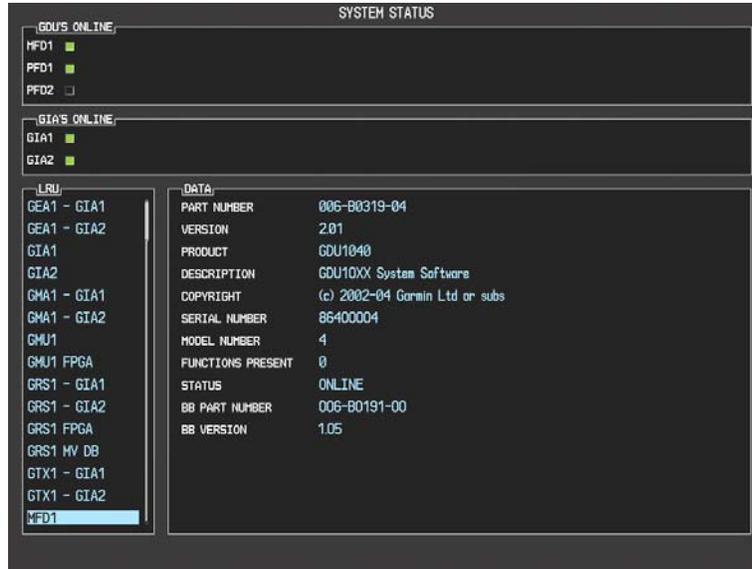
Figure 8-1. (SW v0321.19 or earlier)  
System Status Page (Configuration Mode)

2. The PFD's System Status page shows a list of LRUs in the LRU window. Activate the cursor and highlight the LRU window. Use the FMS knob to scroll through the list in the window and select the following LRUs.

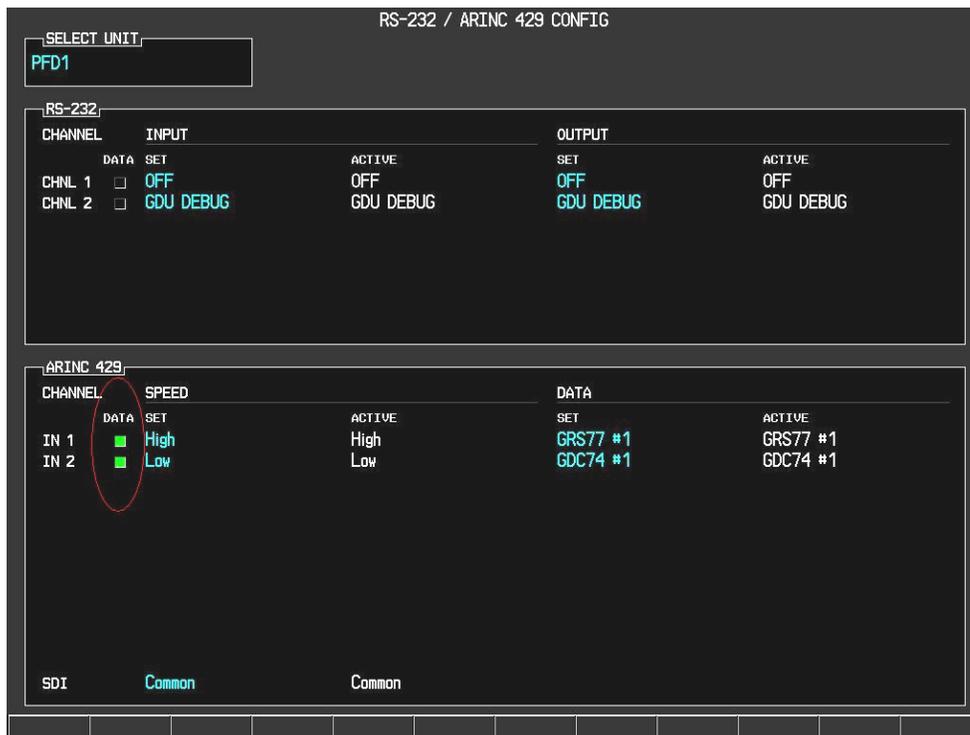
4. Verify both indicators are GREEN, indicating the channels are receiving data as shown below:

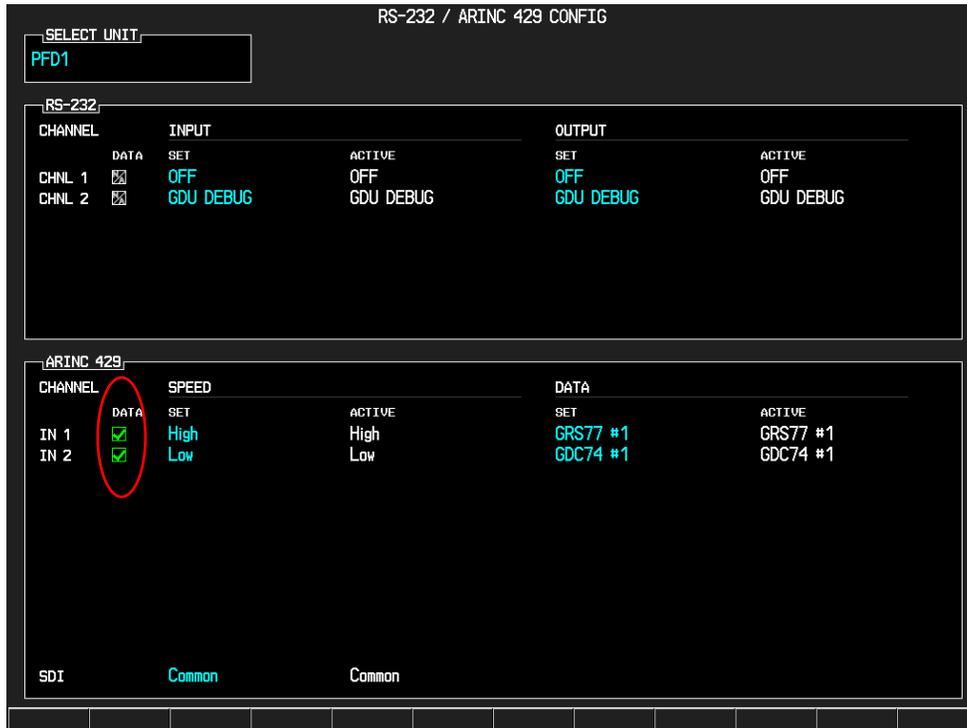
5. Verify all DATA indicators for configured channels have a GREEN CHECK inside the box which indicates the channels are receiving data as shown:

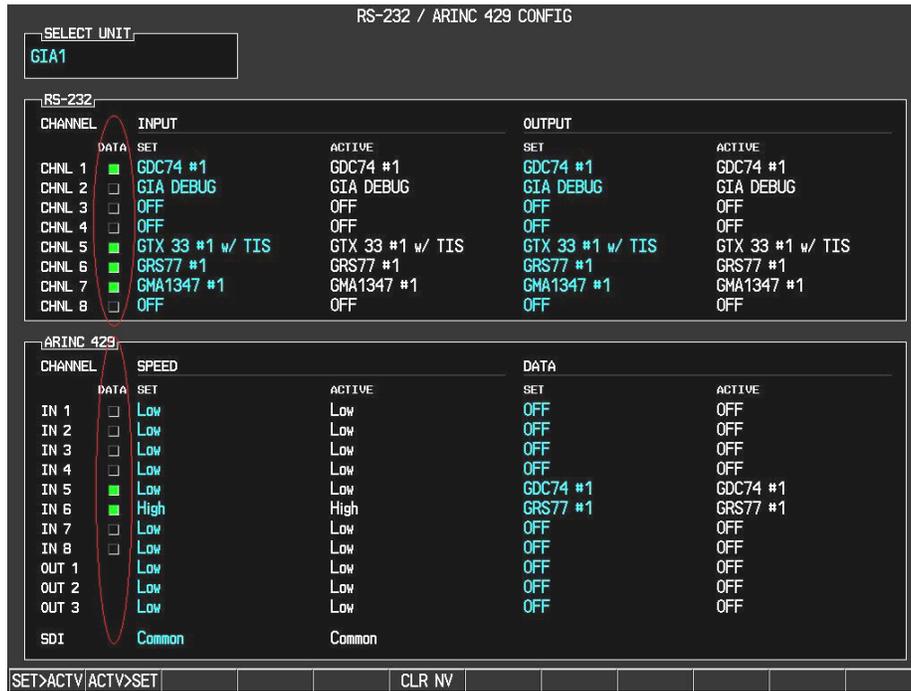
11. Verify all DATA indicators for configured channels are GREEN, indicating the channels are receiving data as shown below:

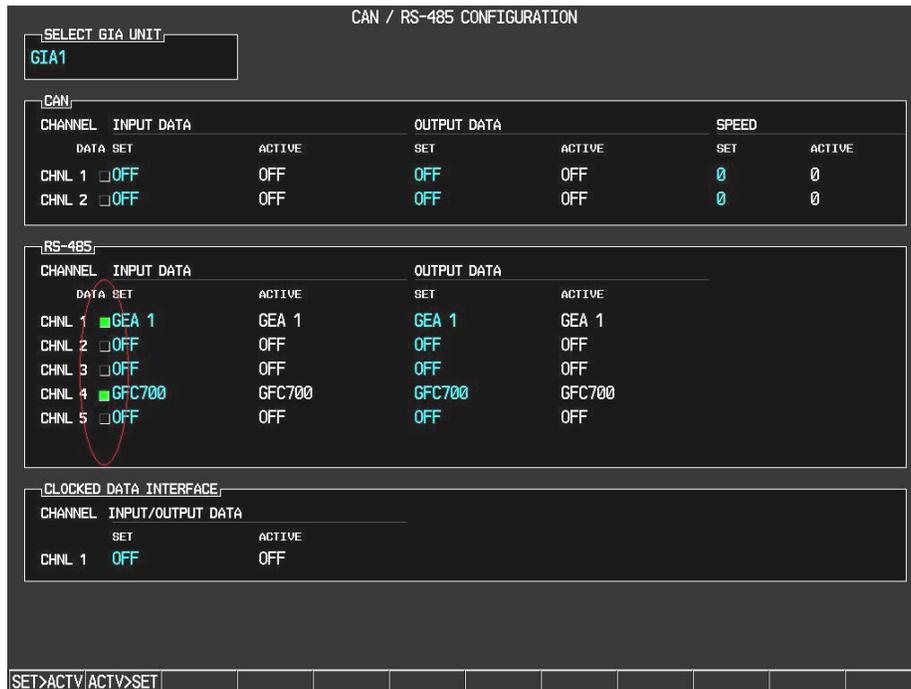
15. (SW v0321.19 or earlier) On the PFD, go to the CAN / RS-485 CONFIGURATION page in the GIA Page Group.  
 (SW v0321.22) On the PFD, go to the RS-485 CONFIGURATION page in the GIA Page Group.
16. Verify that GIA1 is selected in the SELECT UNIT field.
17. Observe the data indicators for all configured RS-485 channels.  
 (SW v0321.19 or earlier)
18. Verify all DATA indicators for configured channels are GREEN, indicating the channels are receiving data as shown:

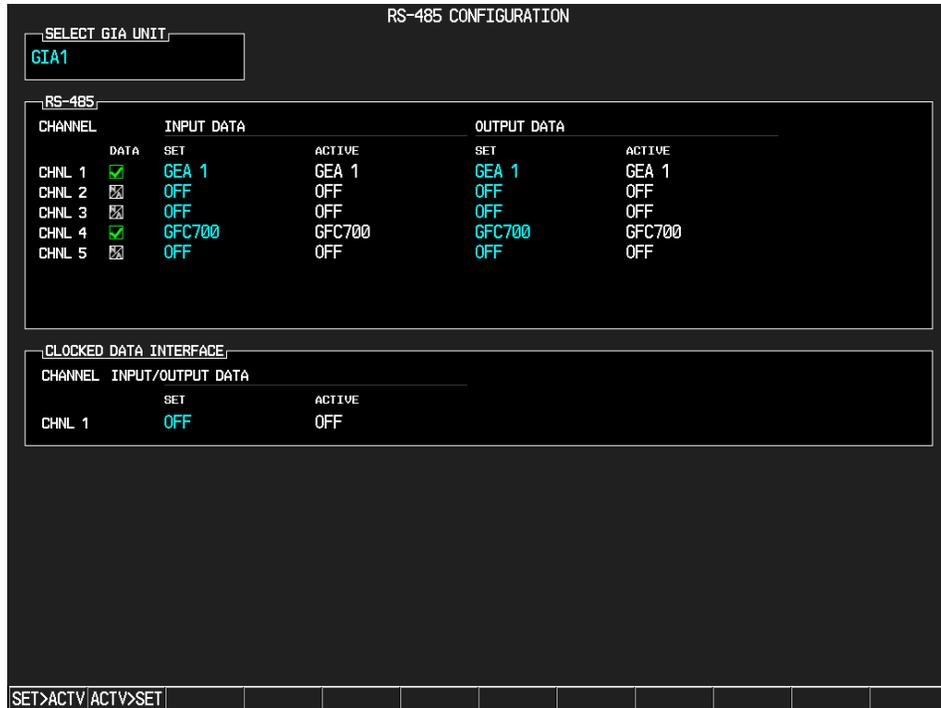
19. Verify all DATA indicators for configured channels have a GREEN CHECK inside the box which, indicates the channels are receiving data as shown:

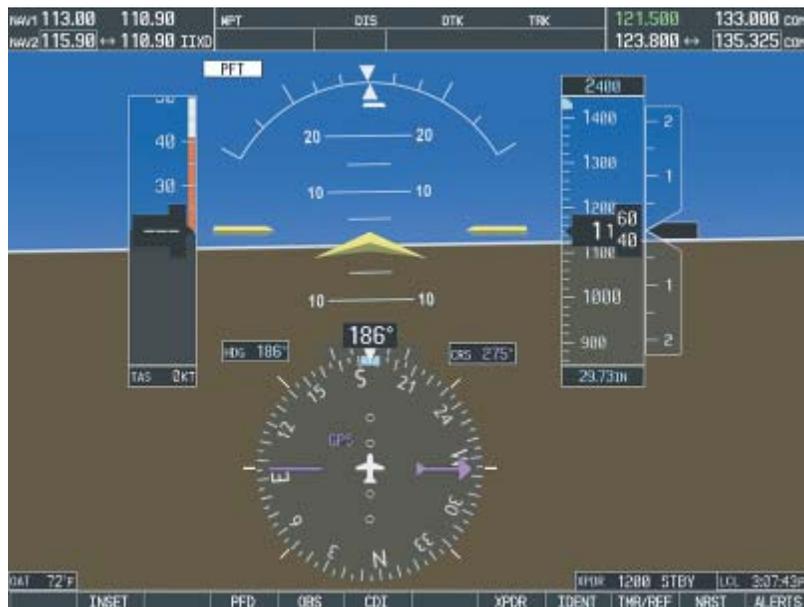
Figure 8-3. Pre-Flight Test

1. Power down the G1000 system using the Avionics Master, then the BAT-side aircraft master switch. If a ground power unit is being used, it too must be powered off. Wait 30 seconds then restore power to the system. The GFC 700 will begin an automatic pre-flight test after AHRS and ADC parameters become valid.
2. Verify that a white 'PFT' annunciation is displayed on the PFD, as shown in Figure 8-3.

A red AFCS ( AFCS ) annunciation may be displayed momentarily before PFT starts. This indicates that the Autopilot and Manual Electric Trim are not available (due to AHRS initialization, GFC 700 system failure, power loss, or because PFT has not been performed)
